# Building Inspection

Inspection Date: 30 Nov 2022

## Forsyth Inspections

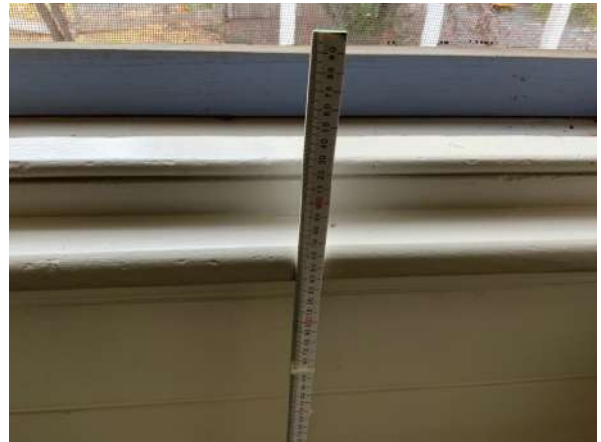
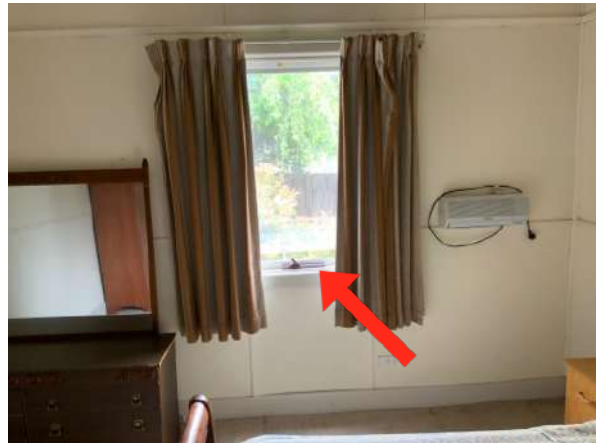
### Safety Hazard 1.01

The windows and balcony were measured and found to be more than the present building regulation requirement of 125mm opening sphere width. This only applies when the external or internal falling distance to the ground is greater than a meter and the window and hand rail is less than 1 meter high inside and a falling distance greater than 1 meter (this includes furniture or something that you can climb on to get access to the window opening).

This defect creates a potential safety hazard in where a person could fall from the upper story and possibly sustain serious injury or death. It's strongly recommended that a registered builder should be contacted and appointed to discuss possible rectification solutions immediately to ensure these windows meet present building standards and regulations.

Please note: If this defect issue is not fixed as a matter of urgency this defect could be become potentially a high safety concern.

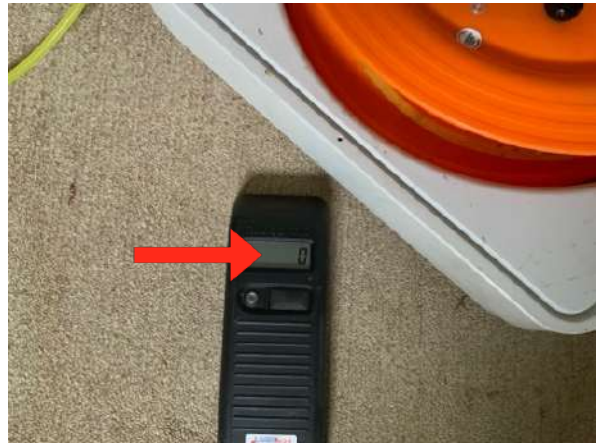
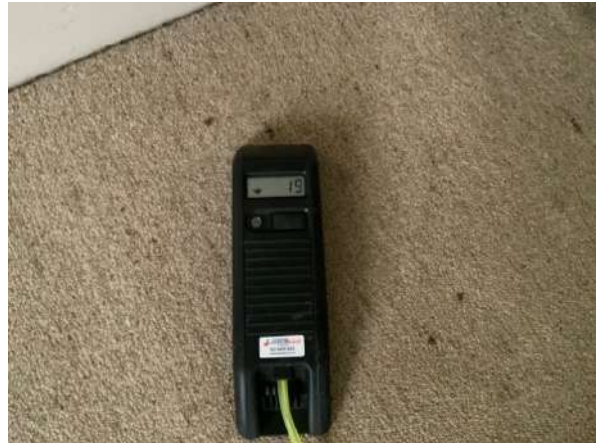
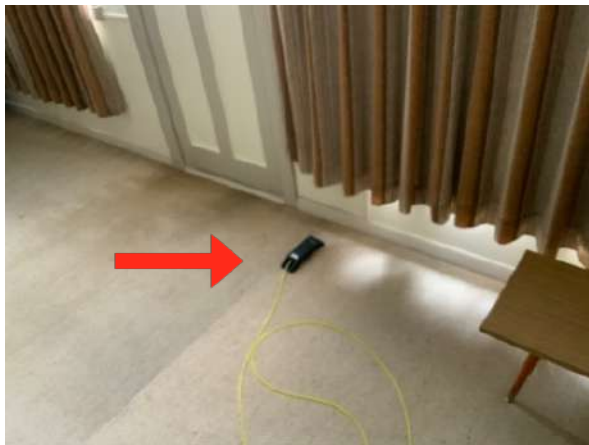
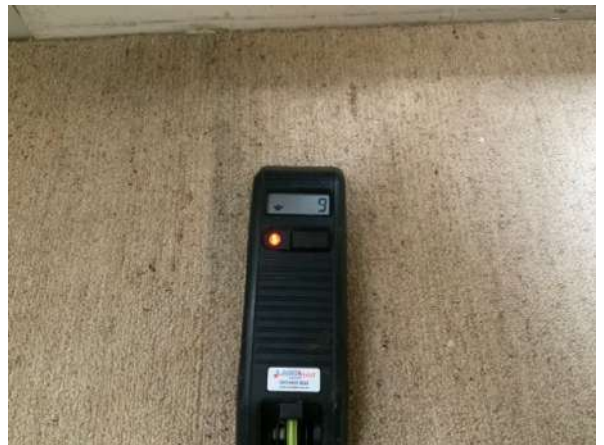
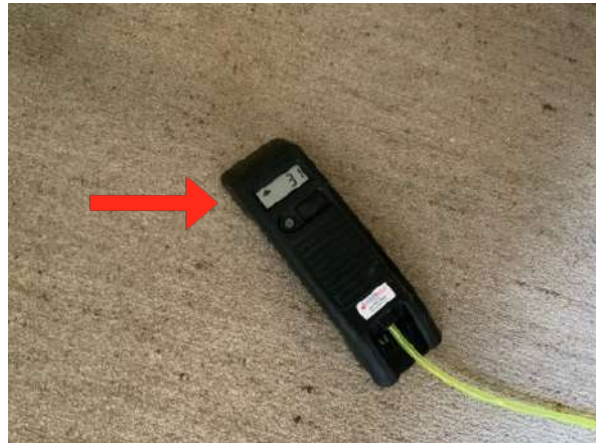
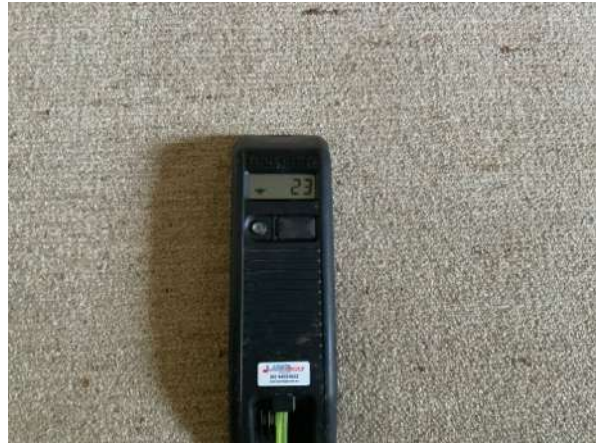
### Major Defect 2.01

The internal flooring in these areas is out of level and uneven. Uneven flooring is likely to indicate minor to major defects such as expected movement of the foundations of the property, but may also indicate subsidence of the associated subfloor structures.

An automatic digital level was used on the day of the inspection to assess the levels through the property internal flooring. Measurements shown are in mm and the photo of an orange wheel in a box is the reference datum first level is taken to set the first height. You have to take into account the difference in floor coverings like timber floor to carpet which could be 15mm - 30mm in height difference.(it's advised for more information about this please give me a phone call to further discuss).

Where flooring is uneven further, potentially invasive inspection of the subfloor structures and stumps in these areas is required. In this case, works to repair are likely to be required, and would be carried out by a registered builder specialising in re-stumping.

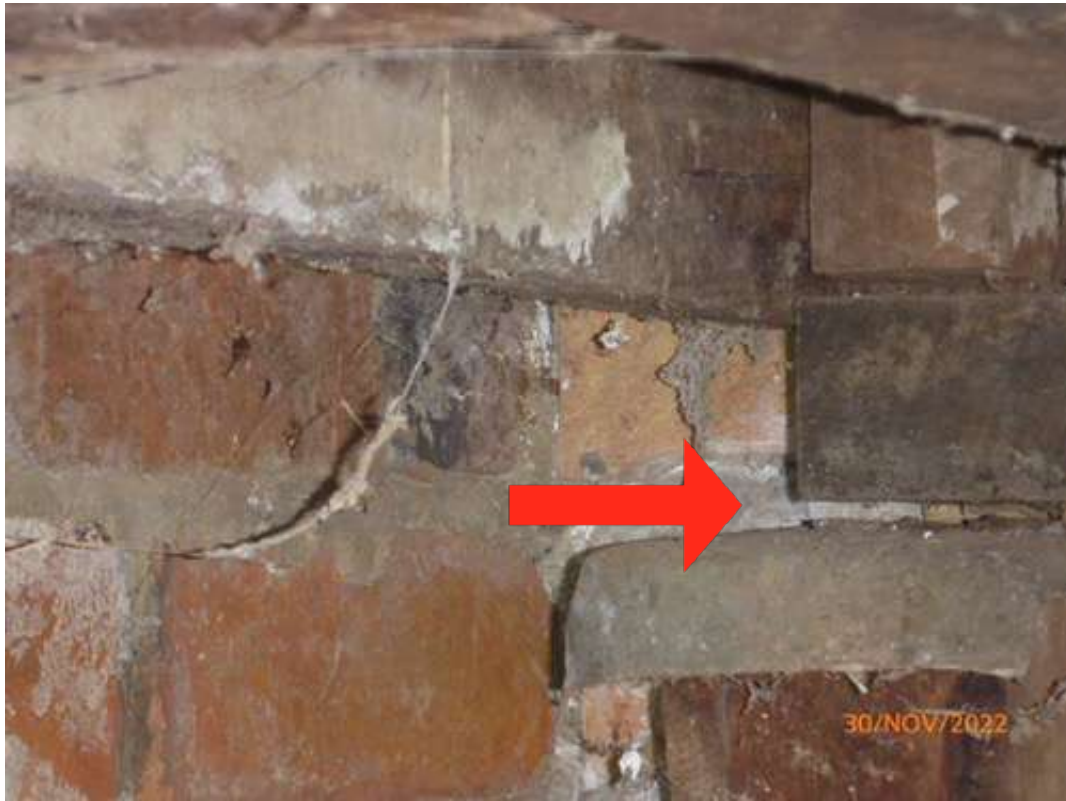
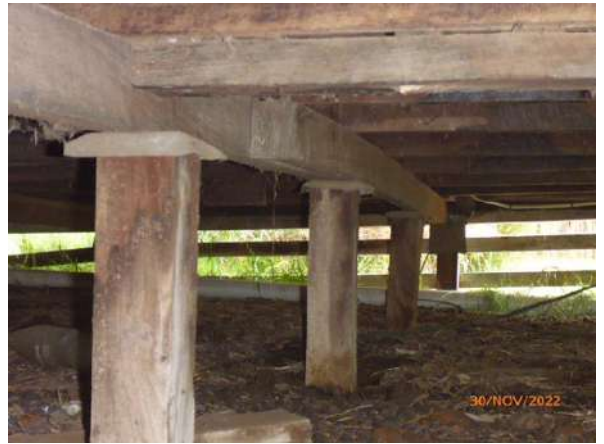
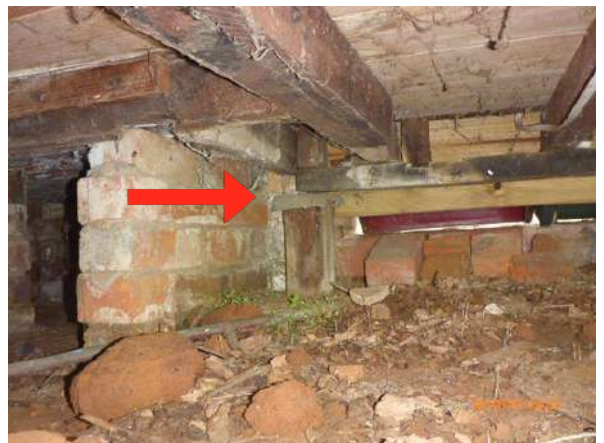
## Major Defect 2.02

**Location:** Subfloor  
**Finding:** Timber stumps - Suspected deterioration

It was noted that the property has timber stumps. Inspection of the condition of the timber stumps - below the surface of the ground - is excluded from the scope of this report. However, it is suspected that several timber stumps are deteriorating, evidenced by secondary defects such as uneven flooring, visually-observable subsidence or major cracking within the property. Even without these secondary defects, deteriorated stumps may still be present.

Where timber stumps are failing, a high degree of maintenance or even replacement of stumps may be required in the short- to medium-term future. It is probable that there is some degree of wood rot or deterioration beginning to occur in areas that are currently inaccessible for inspection. Timber stumps are no longer used in current building practices due to their susceptibility to wood rot and deterioration over a prolonged period of time.

The client should be prepared that in purchasing a property with timber stumps, that they need to restump the property as it's required immediately as an extreme high priority by a licensed re-stumper.

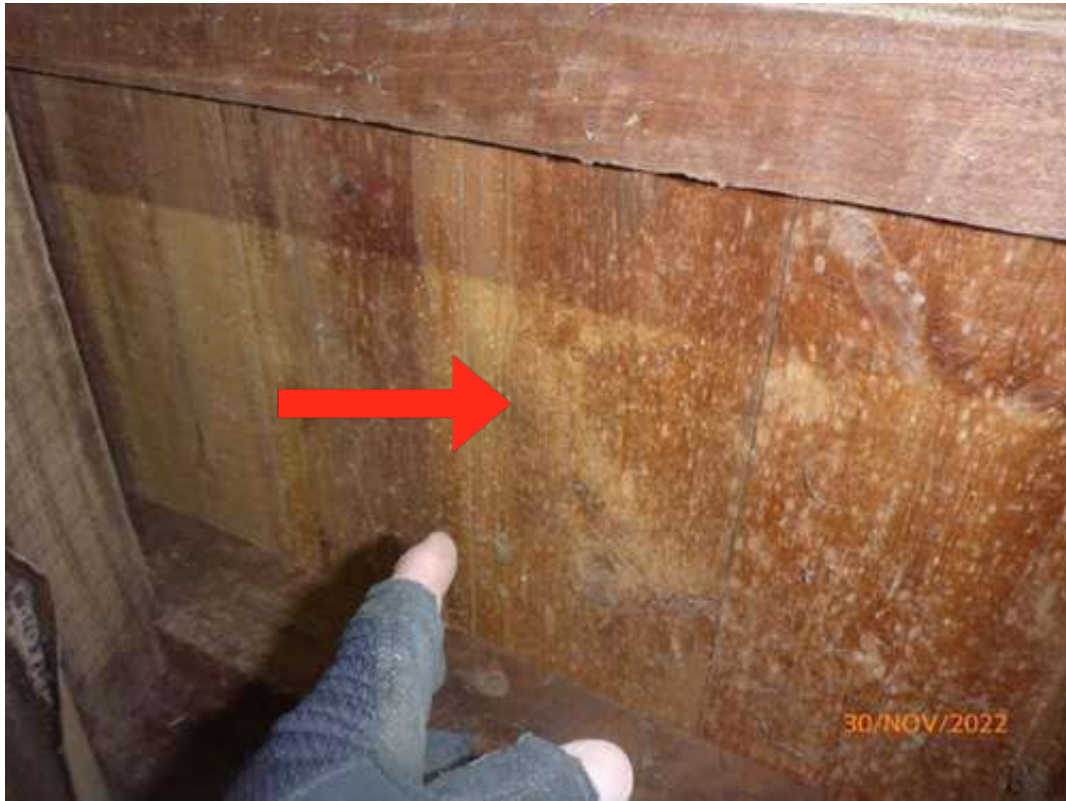
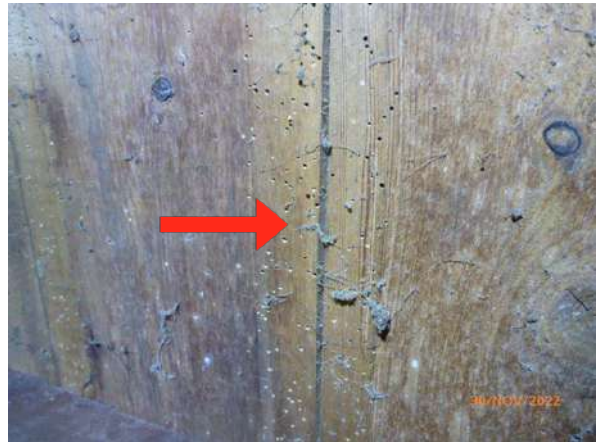
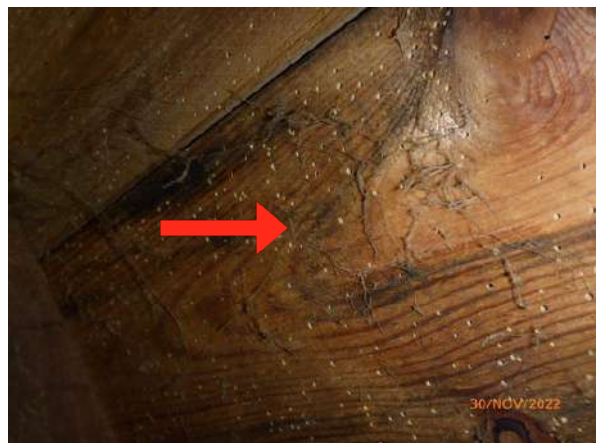
## Major Defect 2.04

**Finding:** Suspected timber pest damage in a number of areas

A number of areas are showing evidence of previous or current pest damage (not all areas of concern may be shown, a few areas are shown with photo evidence for an example).

It's strongly recommended to appoint a licensed pest controller into further investigate this matter and make the required recommendations.

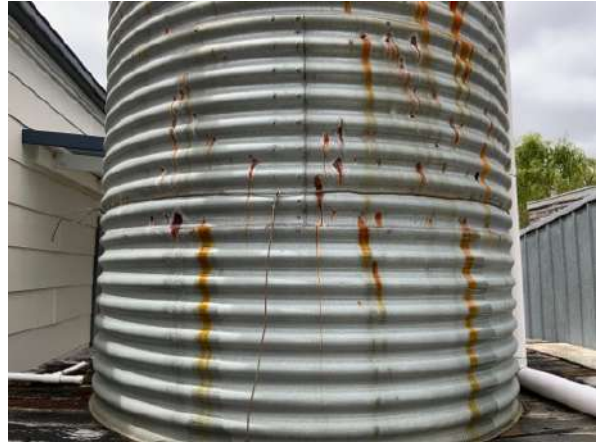
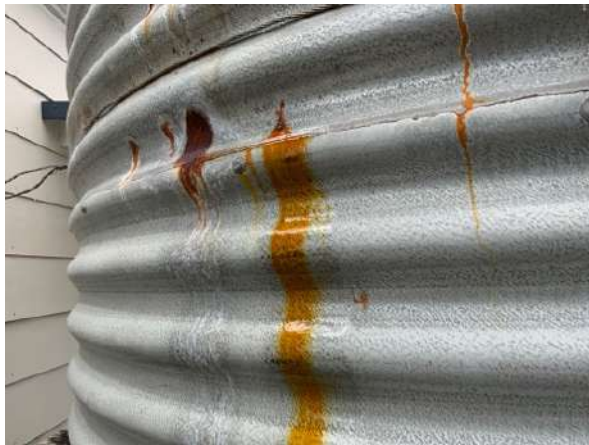
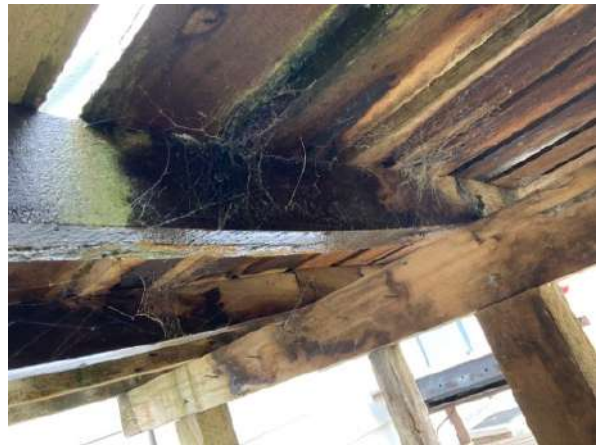
## Major Defect 2.05

**Location:** Yard  
**Finding:** Water tank leak

This rain water tank has a small ongoing leak. You will need to appoint a qualified plumber in the short term to fix this issue.

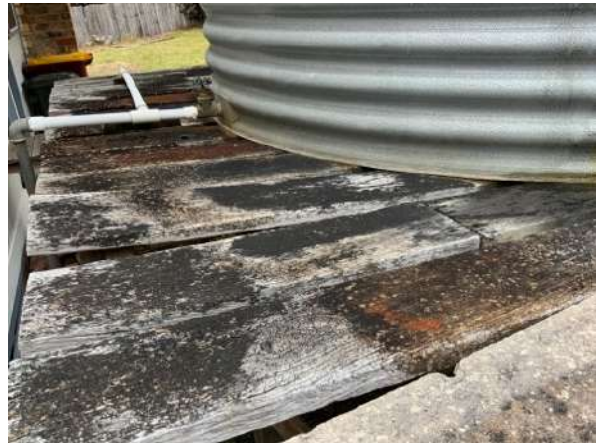
## Major Defect 2.06

**Finding:** Water tank stand damaged timbers structures

The timbers holding the heavy rear rainwater tank up are damaged and should be replaced immediately. The high tank stand should be removed from this location and be relocated away from the house it could potentially fall and seriously hurt someone and damage the property.

It's strongly recommended to appoint a licensed builder and licensed plumber immediately to fix this safety defect.

It is highly advised that a licensed builder be appointed to rectify this issue immediately.

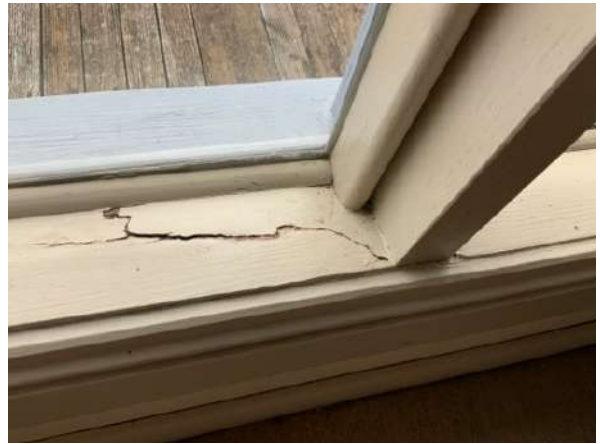
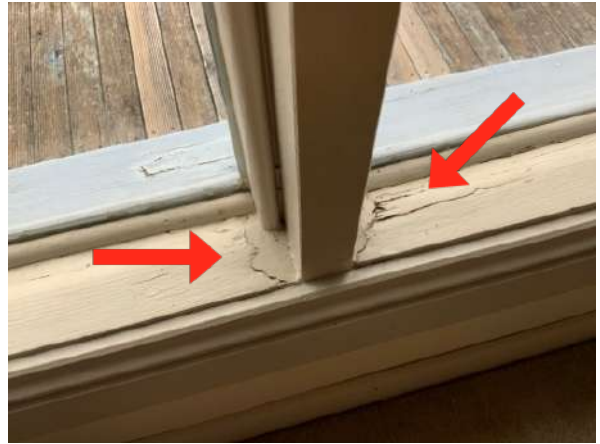
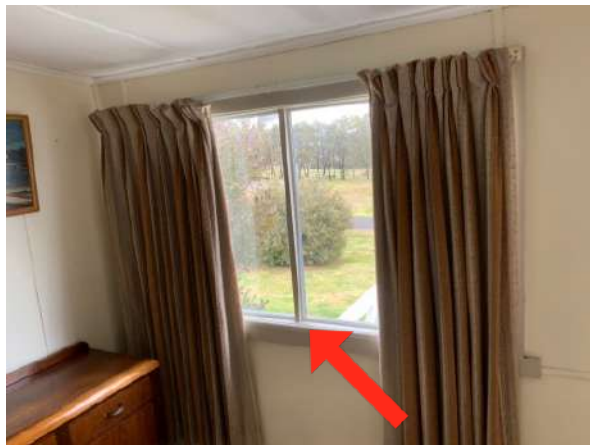
## Major Defect 2.07

**Location:** Lounge room  
**Finding:** Windows Wood Rot (internal)

Wood rot was found to be affecting internal windows. Wood rot, also known as Fungal Decay, occurs when timbers and other cellulose building materials are exposed to damp conditions on an ongoing basis.

It is likely that this wood rot has developed as a result of frequent exposure to rain and other weather conditions from the windows leaking or build up of internal condensation over a long period of time. It is suspected that failure to maintain the window frames over a prolonged period has resulted in them deteriorating at an accelerated rate, increasing their susceptibility to the development of wood rot.

Early intervention and regular maintenance will prolong the useful life of these building elements.

Repair and/or replacement of affected window frames may be a necessary step in protecting surrounding building elements from such deterioration. Remedial works should be performed by a qualified carpenter or an experienced handyman in the near future to prevent any further damage.

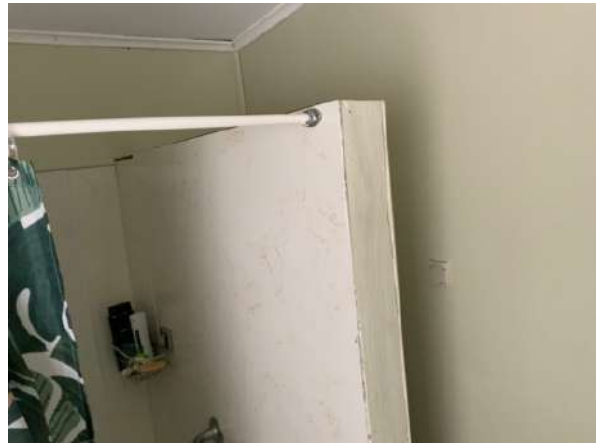
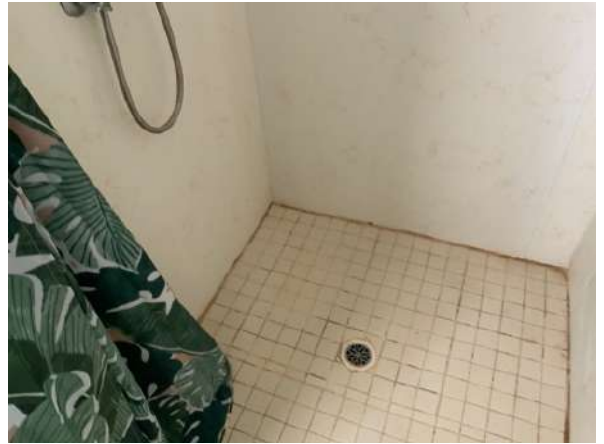
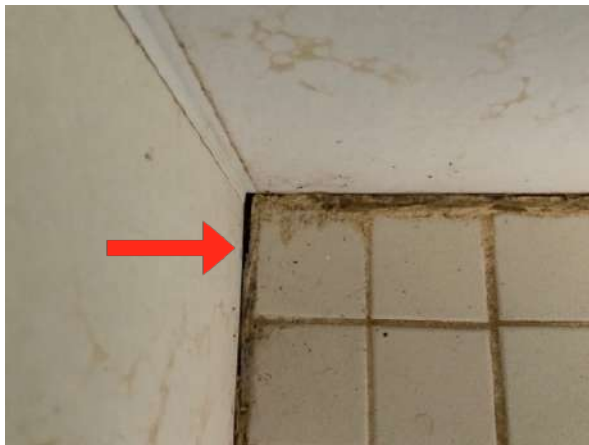
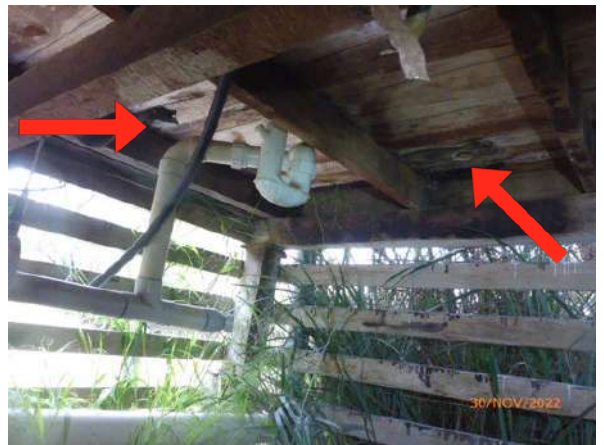
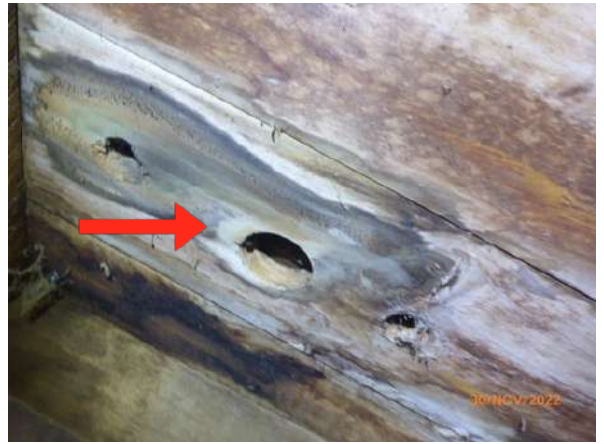
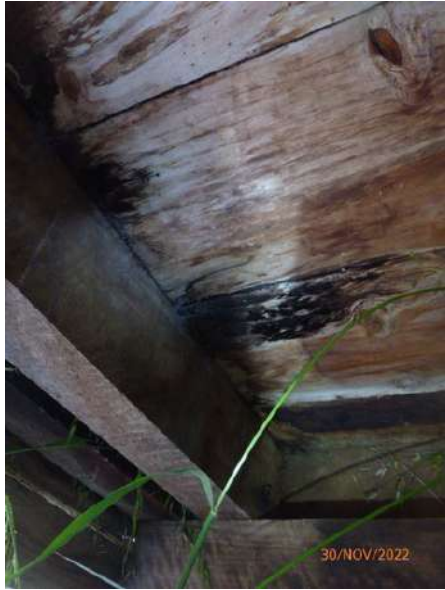
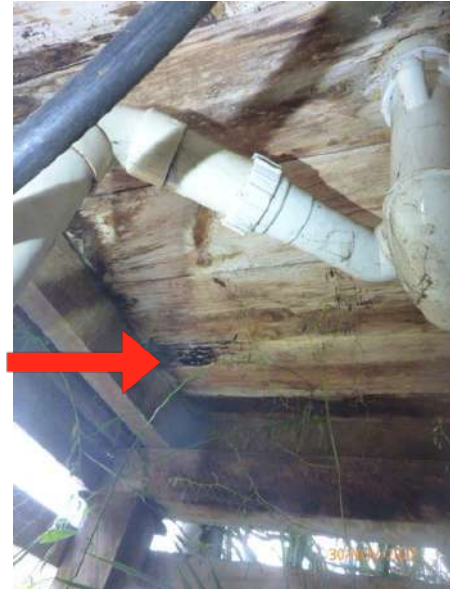
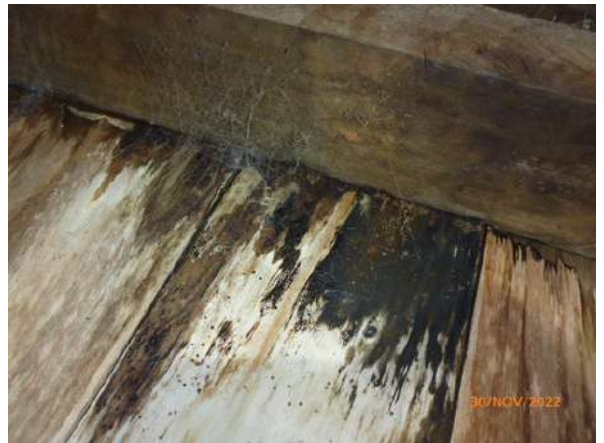
## Major Defect 2.08

**Finding:** Shower water leak (underside evidence moisture, no structural damage)

The underside of the shower area shows evidence of a past or current water leak which appears to have not caused any major wood or structural damage to the building material in this area at the time of the inspection. It's highly recommended to appoint a licensed plumber and a licensed builder into further investigate the water leak and make the required recommendations as soon as possible.

When inspecting the inside of the shower area it was noticed large gaps of missing grout or silicone. The side wall is not fully fixed into place and moves when the shower head rail falls.

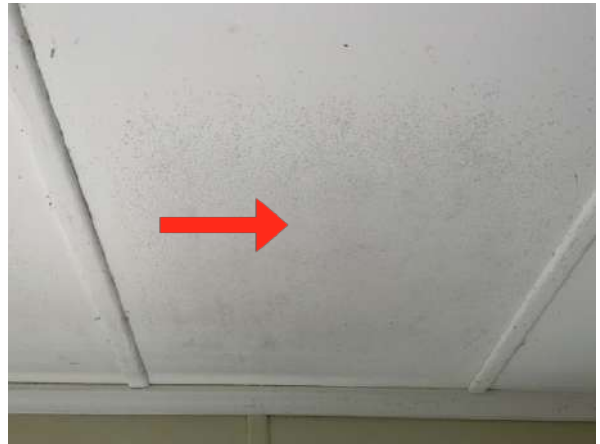
## Minor Defect 3.01

In these areas there appears to be large amount of mould. This could be from lack of ventilation and cleaning.

Generally, the client is advised to ensure that the general environment is free of moisture and humidity to aid in the prevention of mould formation and development. Any mould found during the inspection should be cleaned immediately by a cleaning contractor or the homeowner as applicable. If this is unable to remove this mould or it returns after cleaning than its recommended to appoint a specialist or a qualified environmental health inspector is warranted, where mould is extensive or where any queries regarding air quality spores or other related issues apply.

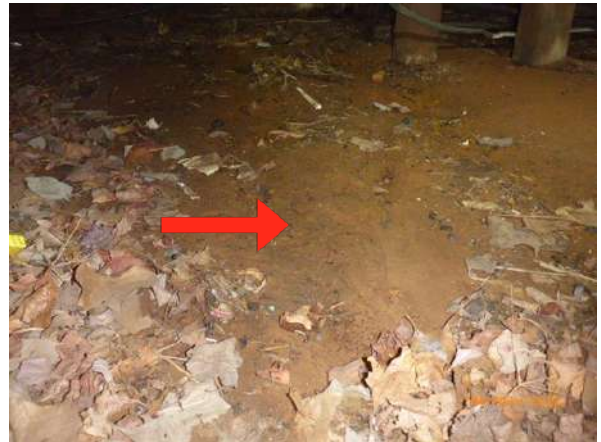
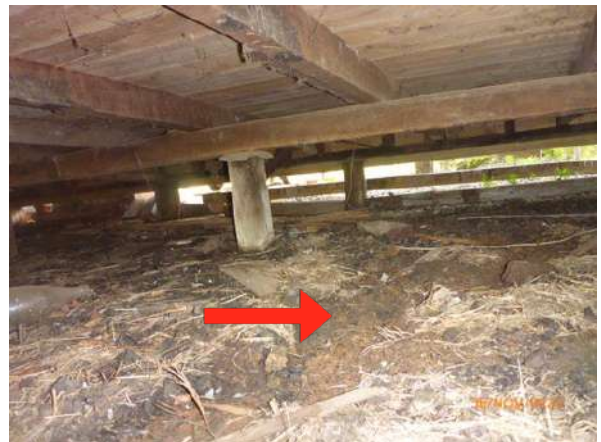
## Minor Defect 3.02

**Finding:** Drainage - Suspected Inadequate

Inadequate site drainage is very common to most homes and was not part of the building regulations when this home was constructed and the responsibility was left to the owner.

It is important that water does not lie underneath the sub floor. If there is a lot of water that continues to lay under the sub floor this may potentially cause the sub floor structures to deteriorate resulting in uneven movement of the footings and foundations, promote wood rot (if timber stumps are present) and attract termite activity.

Where site drainage is inadequate, installation of an Agricultural (Aggie) Drain may be required. A qualified plumber should be appointed to further inspect the property and perform any remedial works as necessary. Water damage and secondary defects are likely to occur if left unmanaged.

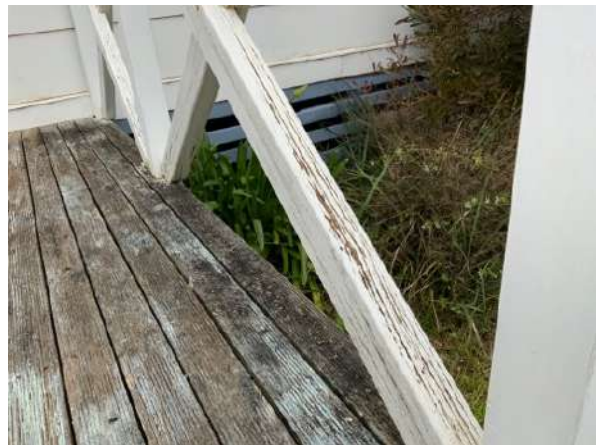
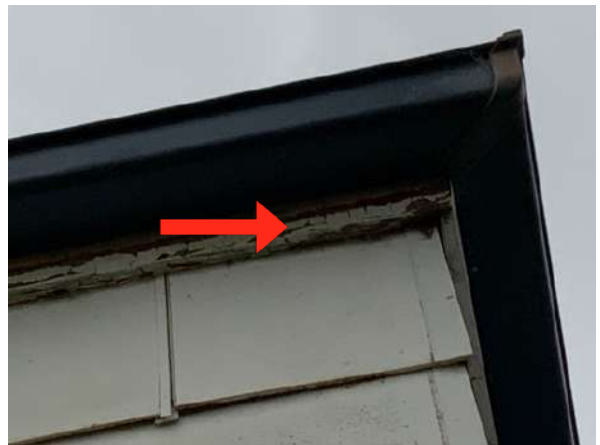
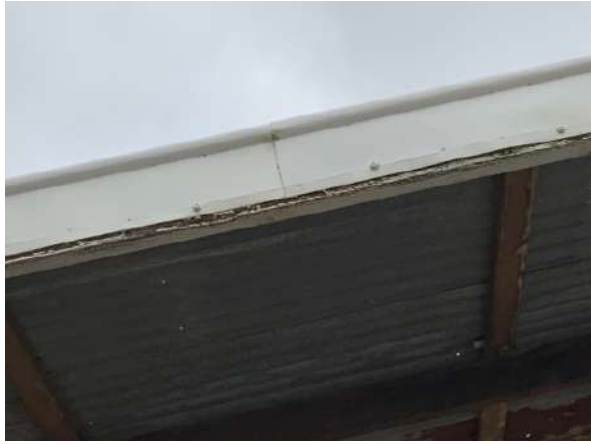
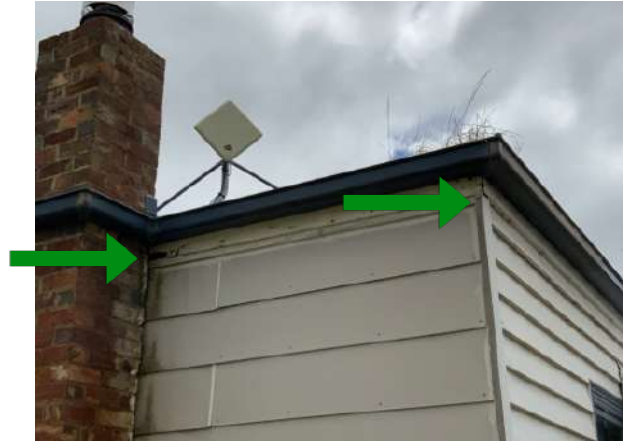
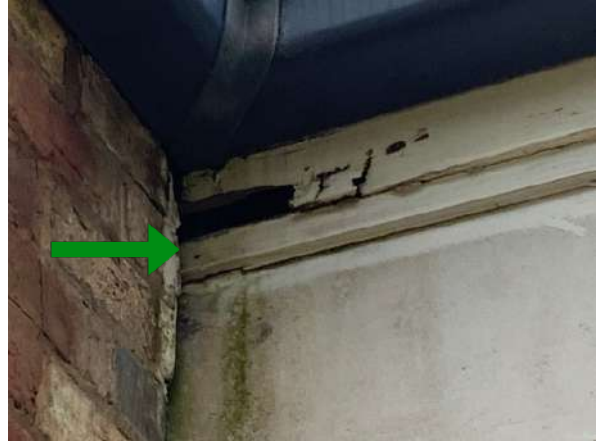
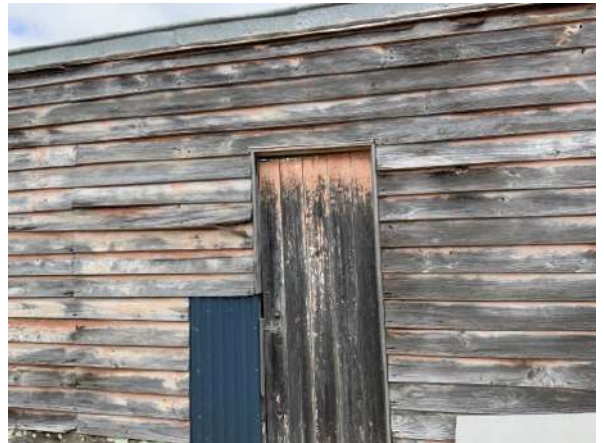
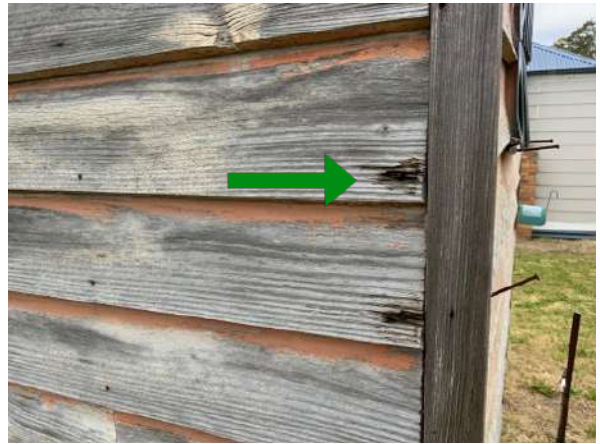
## Minor Defect 3.03

External timbers that are frequently exposed to harsh weather conditions require adequate protection in order to maintain their condition. Where timbers have not been painted or treated adequately, general deterioration is likely to occur at an accelerated rate.

Some of these timbers have developed wood rot (refer to the green arrows), which has progressed over time due to lack of ongoing maintenance. Wood rot, also known as Fungal Decay, occurs when timbers and other cellulose building materials are exposed to damp conditions on an ongoing basis.

If left unattended, replacement of these timbers is likely to be necessary in the short-term. To prolong the life of these timbers it is recommended you seek the services of a painting contractor or general handyman as a short term priority.

A qualified carpenter or registered builder may be required to replace affected building materials.

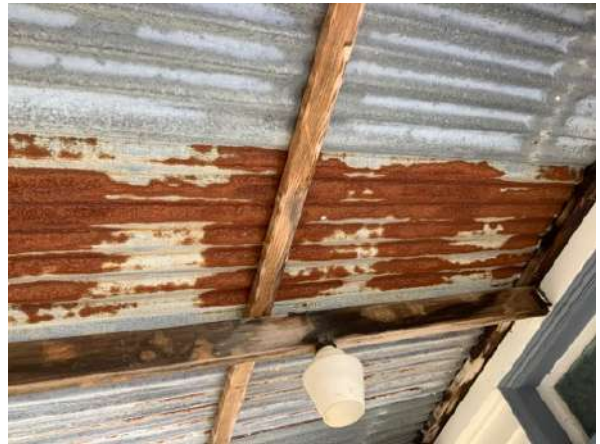
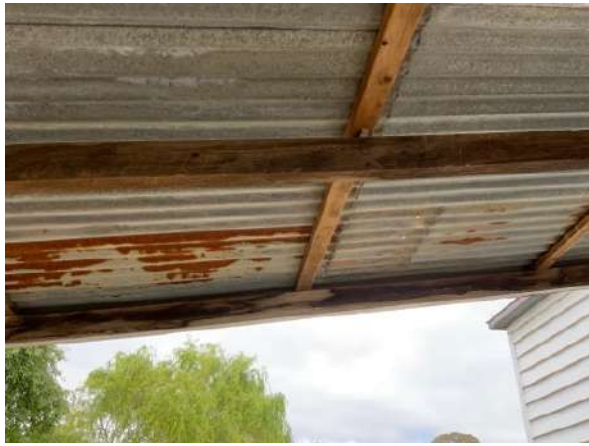
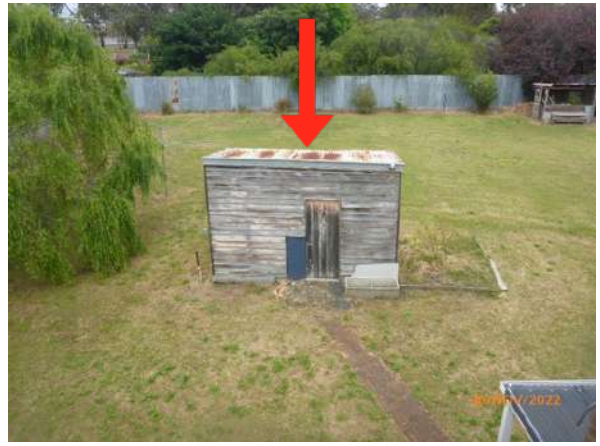
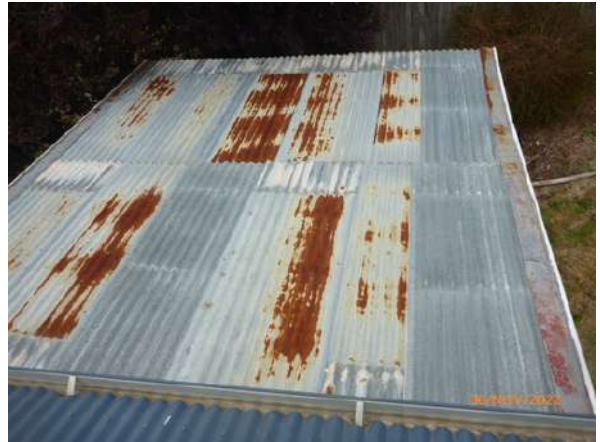
### Minor Defect 3.04

**Finding:** Roofing iron rusted

The roof plumbing has minor to major areas of rust and corrosion. It is suspected that this has been caused by general age and deterioration.

Rusted roof plumbing will generally develop holes and leaks that can affect other building elements with poor drainage of storm water. Poorly drained roof areas will also lead to damp conditions surrounding the base perimeter of the building which, if left unmanaged, can lead to a range of secondary building defects.

Repair and/or replacement of rusted roof plumbing is highly required in order to reinstate the roof drainage system to a fully operational level. To further maintain these areas, gutters should be cleaned frequently, allowing the avoidance of any partial blockages.

A licensed plumber or specialist roof restoration company should be appointed to undertake these works. It is advised that such works be completed as soon as possible to prevent any further damage and deterioration.

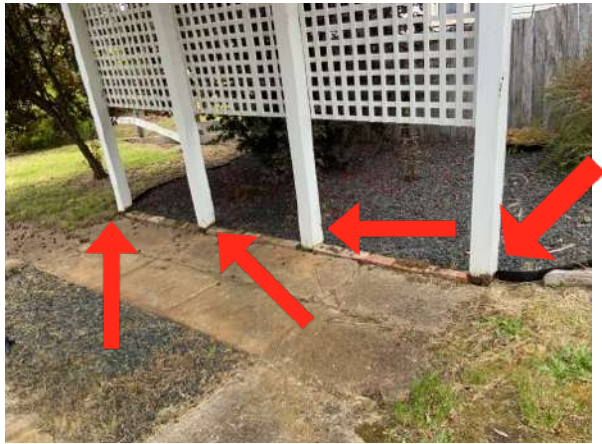
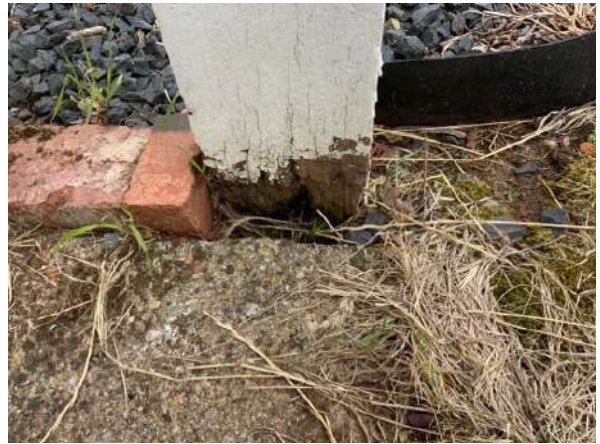
## Minor Defect 3.05

**Finding:** Wood Rot

Some of the building element shows evidence of wood rot throughout the property. Wood rot, also known as Fungal Decay, occurs when timbers and other cellulose building materials are exposed to damp conditions on an ongoing basis. This could be the result of exposure to weathering over a prolonged period of time, or the attraction of excessive moisture from other abutting building materials.

Early intervention and regular maintenance, particularly of exterior timbers, will prolong the useful life of these building elements. Prior to any works being performed, the cause of the moisture that has created the visible wood rot should be identified and addressed in a suitable manner. Replacement of affected timbers may then be a necessary step in protecting surrounding building elements from such deterioration.

A qualified carpenter or registered builder may be required to replace affected building materials.

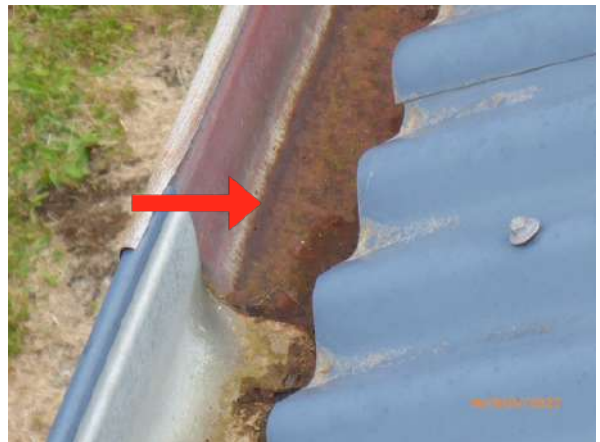
### Minor Defect 3.06

**Finding:** Rusty gutters

The guttering and downpipes on the house are corroded with some holes evident. This should be rectified as soon as possible as excessive moisture can lead to foundation issues as well as conditions conducive towards timber pest activity. An investigation (by a competent person e.g. a licensed plumbing contractor) is recommended as soon as possible to determine the method and extent of any remedial work required and associated costs.

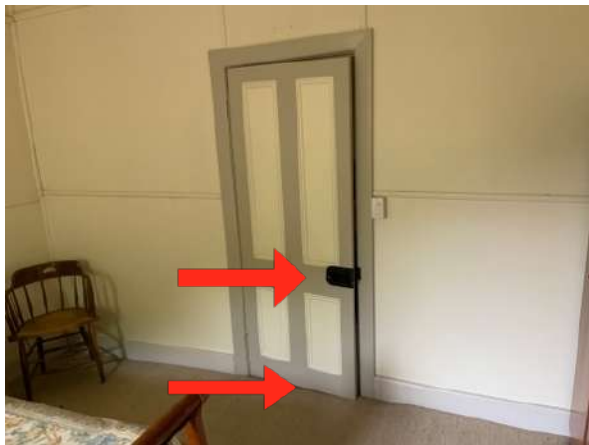
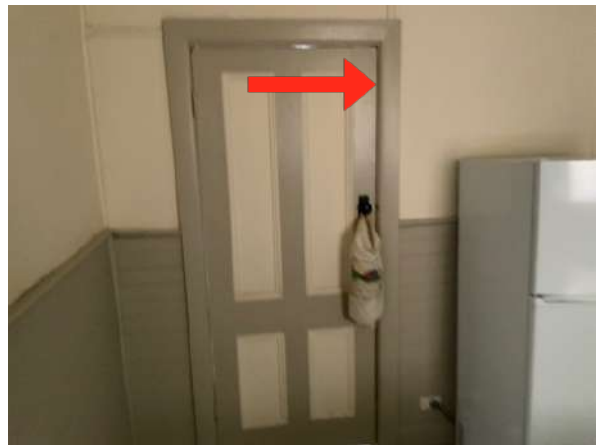
### Minor Defect 3.07

Binding and/or jamming of these doors was evident during standard operation as was misalignment of the striker plates. These defects inhibit the functionality of the affected door as well as creating potential for secondary defects to associated building elements, such as damage to the floor covering.

A door that binds to flooring or to the associated door frame may have several causes, ranging from minor defects, such as poor installation of the door or deteriorated hinges.

This is a common defect and is expected in a property of this age, whether being due to substandard installation or general deterioration of the door hardware.

For minor causes, a qualified carpenter or general handy person should be appointed to perform minor rectification works at client discretion.

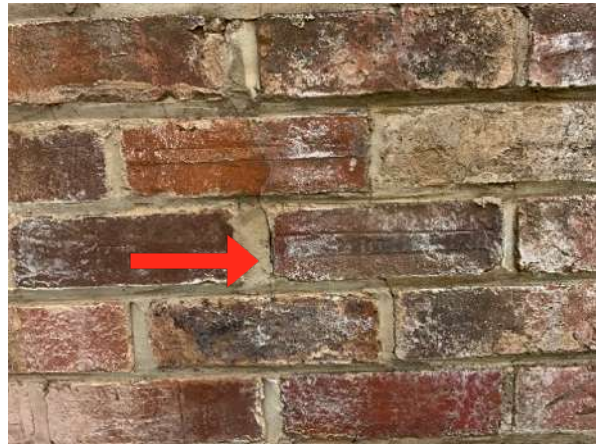
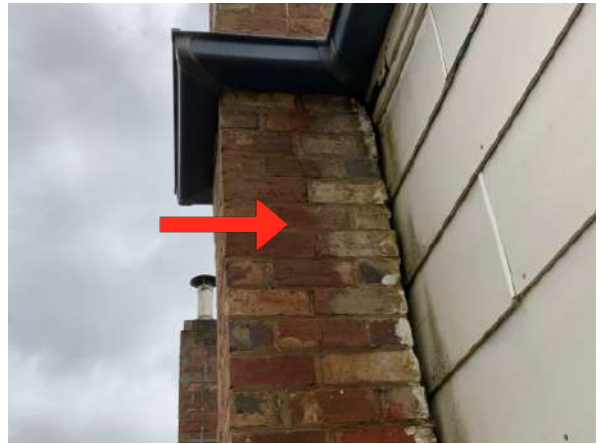
### Minor Defect 3.08

**Finding:** Brickwork - Cracking

Although fine cracks are quite noticeable, they are often only considered to be an appearance defect and usually do not indicate any structural damage. Generally, the cause of a fine crack is indicative of a separation between brickwork and mortar throughout the structure, but single bricks may also show cracks of this nature.

Cracking of this nature can generally be repaired with minor filling and should be conducted by a qualified bricklayer.

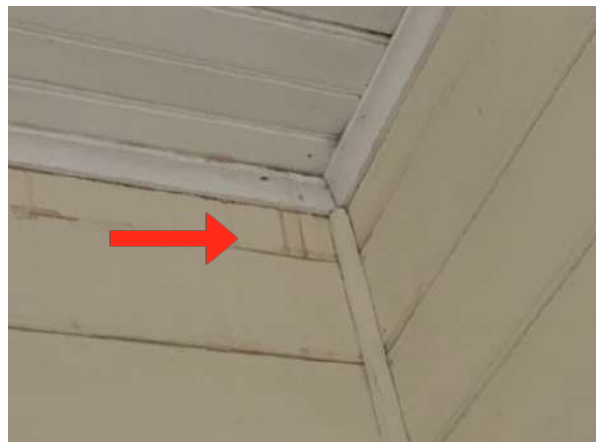
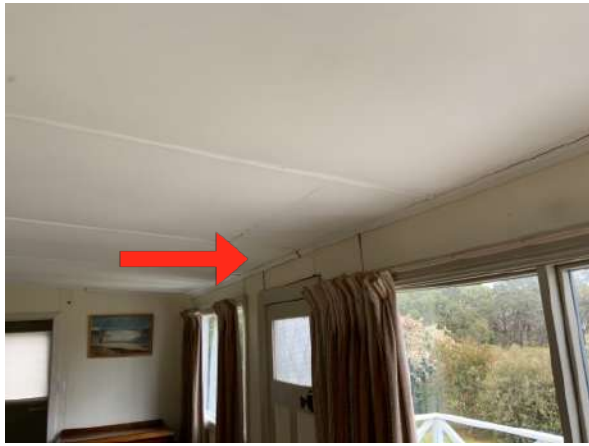
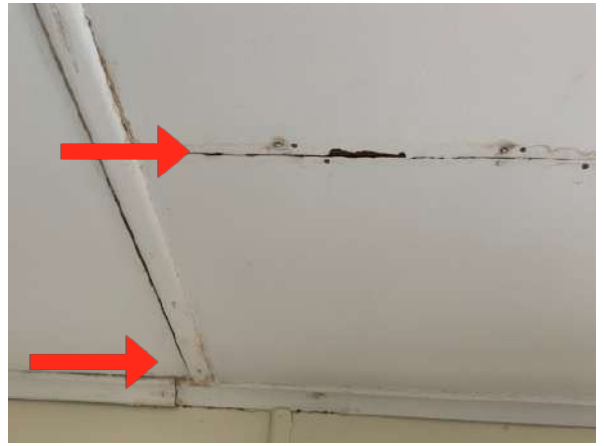
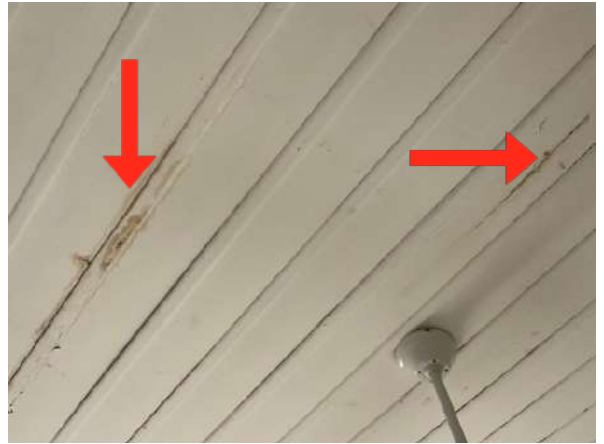
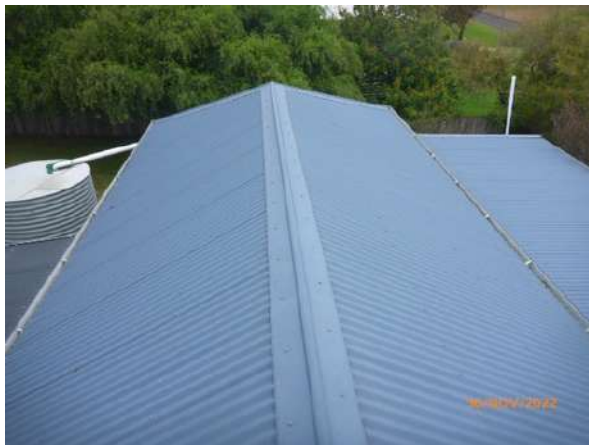
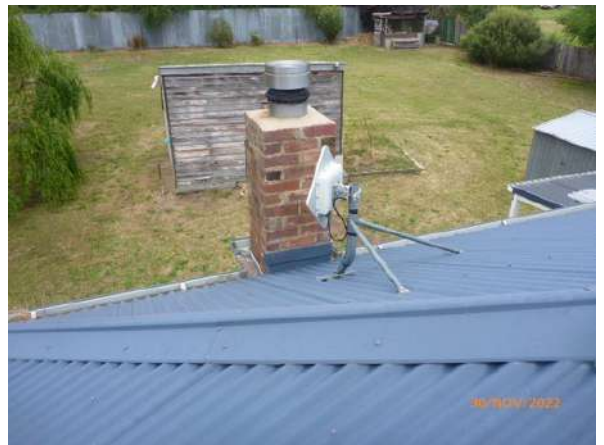
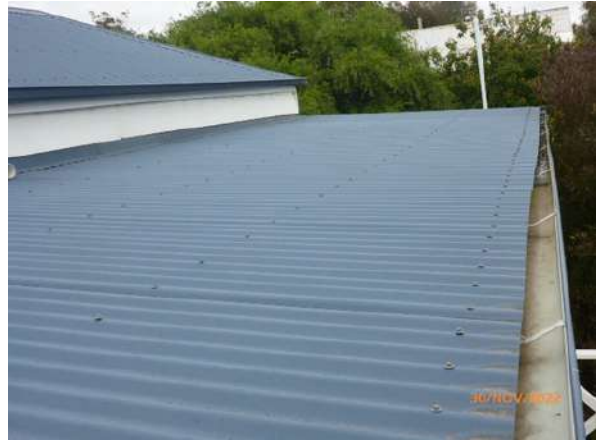
### Minor Defect 3.09

**Finding:** Ceiling - Water damaged (suspected old newer roof)

Water damage to the ceiling lining in this area is generally an indication of excessive moisture being present, usually via a leak to the roof covering; however, when inspecting the external roof it appears that the roof has been recently sometime ago been replaced. It's highly recommended to monitor this defect area over a period of time and if there is any current activity then a roofing plumber should be appointed as soon as possible to identify the leak and perform rectification works as necessary, ensuring the water damage is restricted.

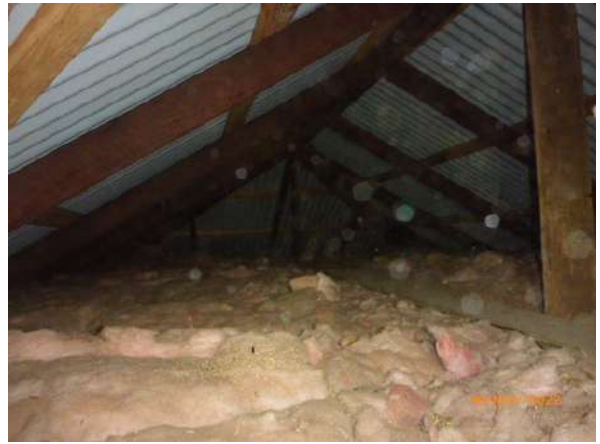
### Observation 4.03

These photographs are an indication of the obstructions and limitations which impeded full inspection of the roof void and subfloor lack of height at the time of inspection. Please refer to the pre inspection agreement.

It is recommended a further inspection of the roof void and subfloor be conducted once suitable access has been provided.

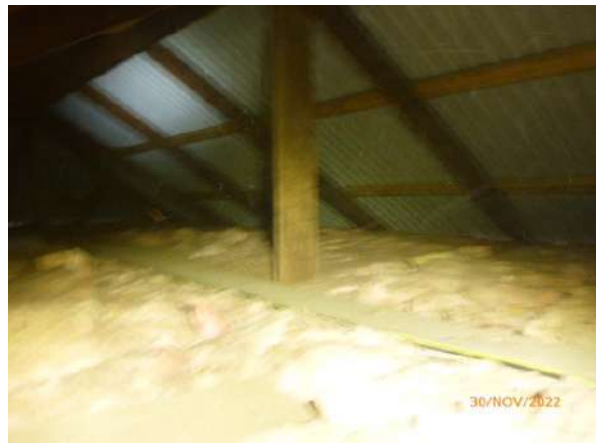
### Observation 4.04

**Finding:** Insulation coverage Upon inspection of the roof void it was noted that there is a good coverage of insulation.

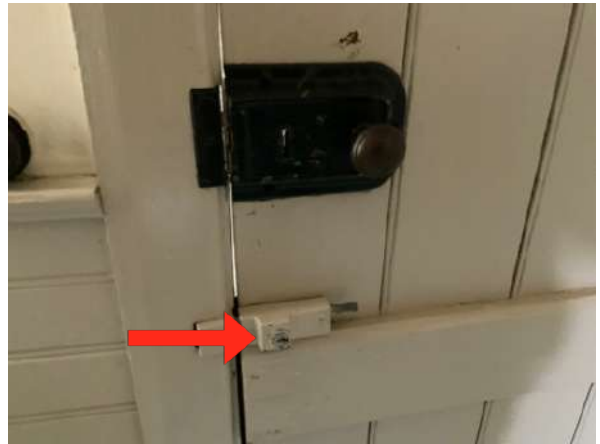
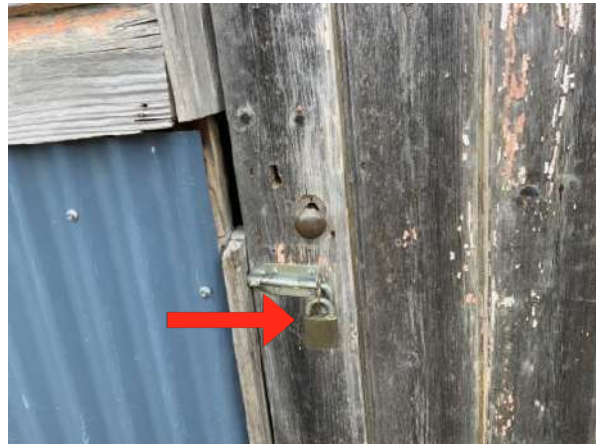
## Observation 4.05

These areas were locked at the time of the inspection. So the area behind the locked door was not inspected.

It's recommended to have this area inspected when this area is fully accessible.
