# Building Inspection

Inspection Date: 30 Nov 2022

## Forsyth Inspections

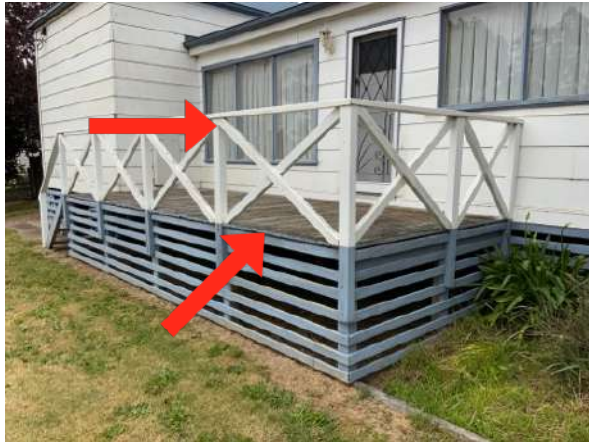
### Safety Hazard 1.01

The windows and balcony were measured and found to be more than the present building regulation requirement of 125mm opening sphere width. This only applies when the external or internal falling distance to the ground is greater than a meter and the window and hand rail is less than 1 meter high inside and a falling distance greater than 1 meter (this includes furniture or something that you can climb on to get access to the window opening).

This defect creates a potential safety hazard in where a person could fall from the upper story and possibly sustain serious injury or death. It's strongly recommended that a registered builder should be contacted and appointed to discuss possible rectification solutions immediately to ensure these windows meet present building standards and regulations.

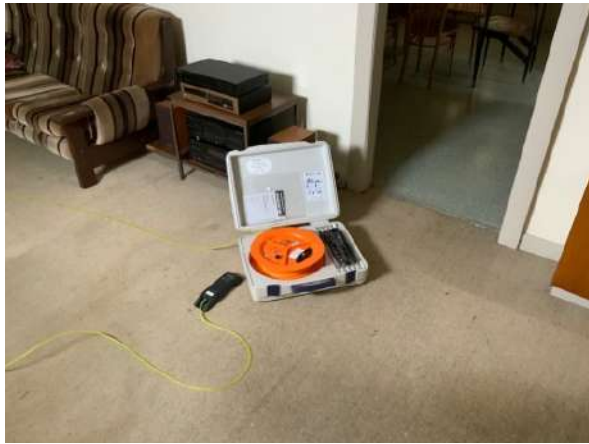
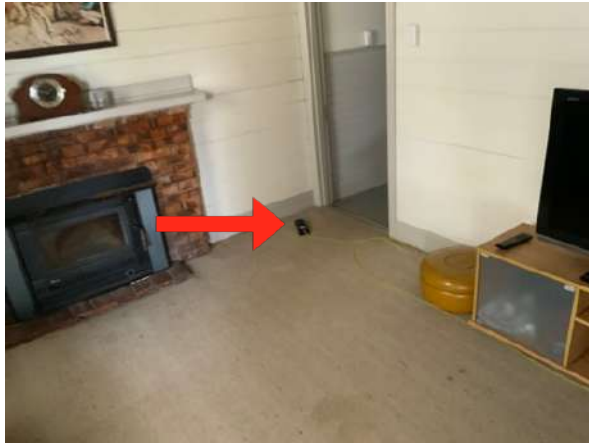
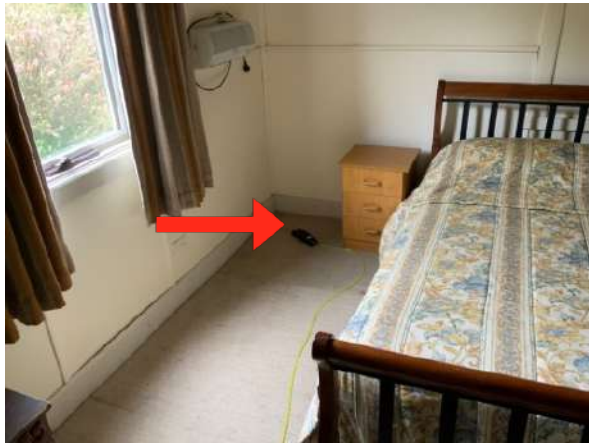
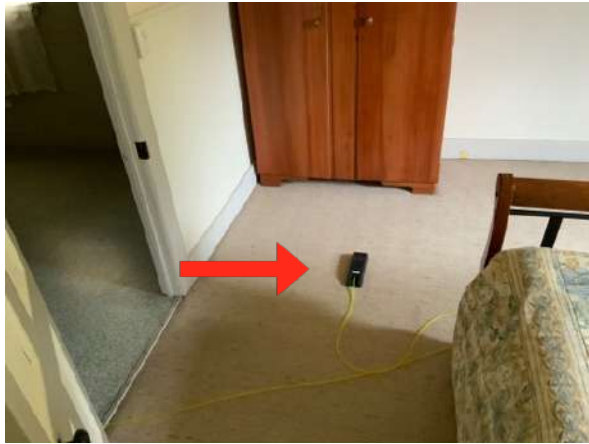
### Major Defect 2.01

The internal flooring in these areas is out of level and uneven. Uneven flooring is likely to indicate minor to major defects such as expected movement of the foundations of the property, but may also indicate subsidence of the associated subfloor structures.

An automatic digital level was used on the day of the inspection to assess the levels through the property internal flooring. Measurements shown are in mm and the photo of an orange wheel in a box is the reference datum first level is taken to set the first height. You have to take into account the difference in floor coverings like timber floor to carpet which could be 15mm - 30mm in height difference.(it's advised for more information about this please give me a phone call to further discuss).

Where flooring is uneven further, potentially invasive inspection of the subfloor structures and stumps in these areas is required. In this case, works to repair are likely to be required, and would be carried out by a registered builder specialising in re-stumping.

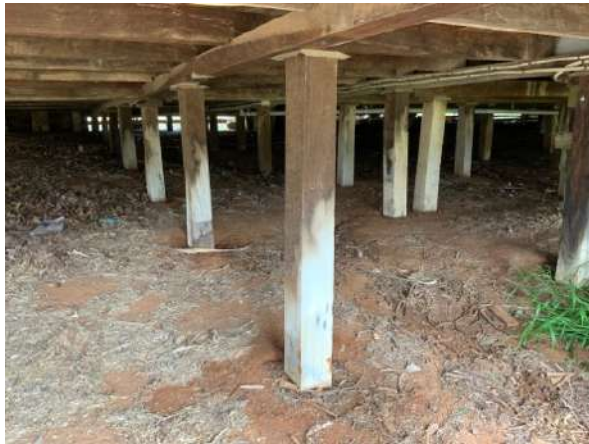
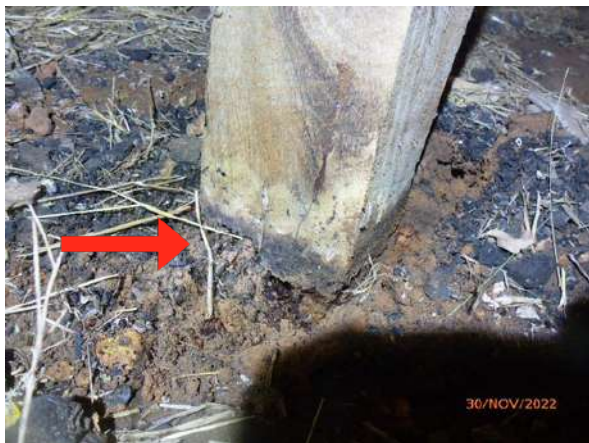
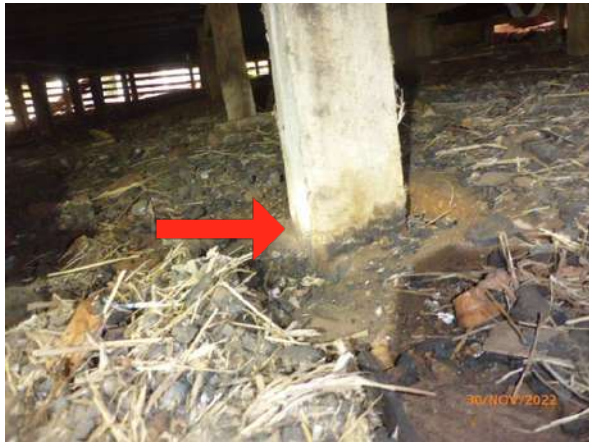
## Major Defect 2.02

**Location:** Subfloor  
**Finding:** Timber stumps - Suspected deterioration

It was noted that the property has timber stumps. Inspection of the condition of the timber stumps - below the surface of the ground - is excluded from the scope of this report. However, it is suspected that several timber stumps are deteriorating, evidenced by secondary defects such as uneven flooring, visually-observable subsidence or major cracking within the property. Even without these secondary defects, deteriorated stumps may still be present.

Where timber stumps are failing, a high degree of maintenance or even replacement of stumps may be required in the short- to medium-term future. It is probable that there is some degree of wood rot or deterioration beginning to occur in areas that are currently inaccessible for inspection. Timber stumps are no longer used in current building practices due to their susceptibility to wood rot and deterioration over a prolonged period of time.

The client should be prepared that in purchasing a property with timber stumps, that they need to restump the property as it's required immediately as an extreme high priority by a licensed re-stumper.

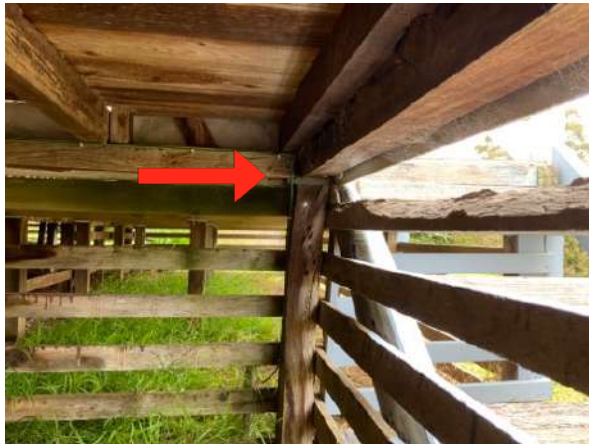
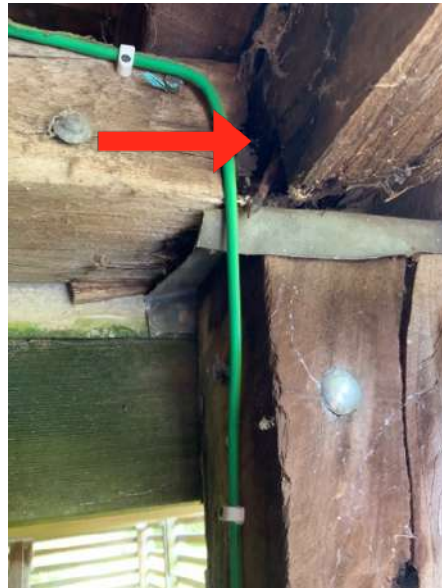
## Major Defect 2.03

**Finding:** Sub floor wood rot

When inspecting this area it appears that this timber bearer has some more serious wood rot to this area. It's strongly recommended to appoint a licensed builder to further investigate this defect and make the required recommendations as soon as possible.

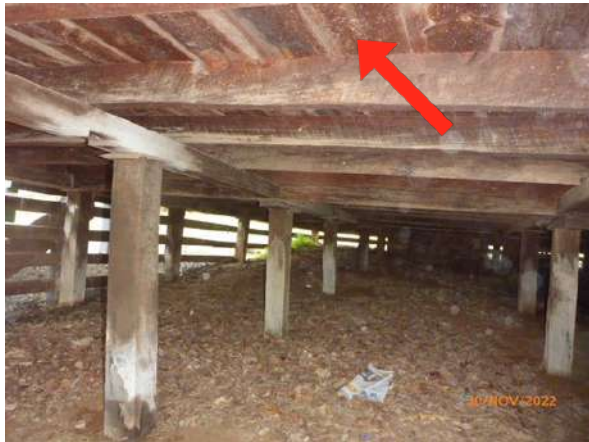
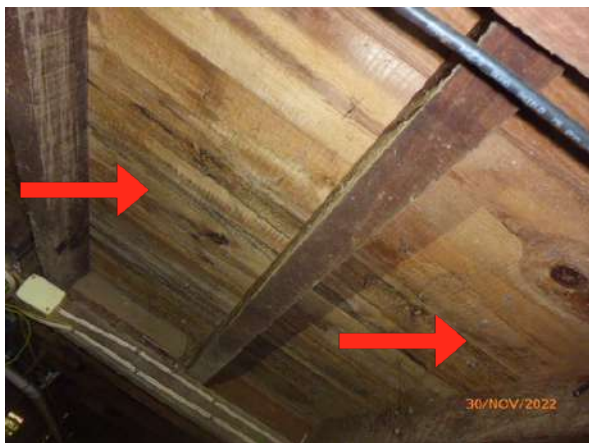
## Major Defect 2.04

**Finding:** Suspected timber pest damage in a number of areas

A number of areas are showing evidence of previous or current pest damage (not all areas of concern may be shown, a few areas are shown with photo evidence for an example).

It's strongly recommended to appoint a licensed pest controller into further investigate this matter and make the required recommendations.

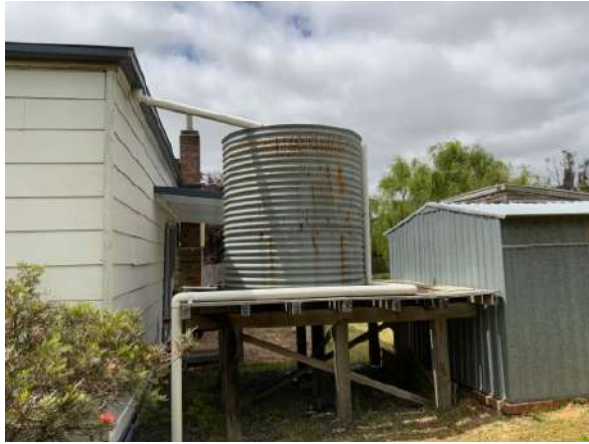
## Major Defect 2.05

**Location:** Yard  
**Finding:** Water tank leak

This rain water tank has a small ongoing leak. You will need to appoint a qualified plumber in the short term to fix this issue.

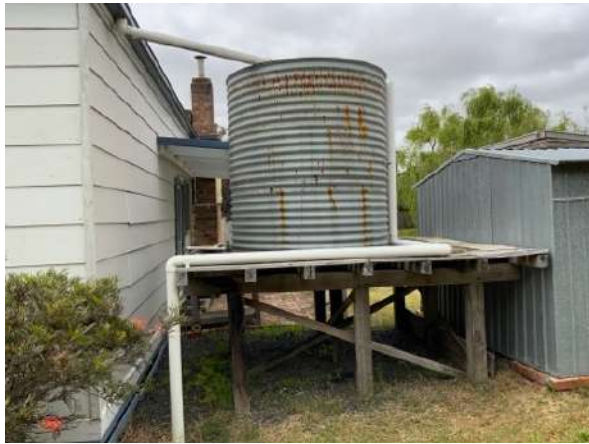
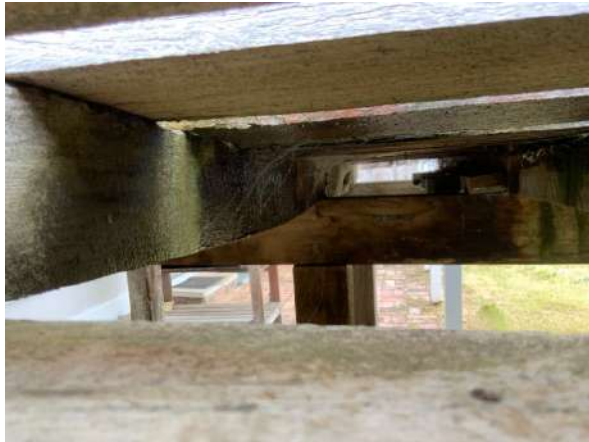
## Major Defect 2.06

**Finding:** Water tank stand damaged timbers structures

The timbers holding the heavy rear rainwater tank up are damaged and should be replaced immediately. The high tank stand should be removed from this location and be relocated away from the house it could potentially fall and seriously hurt someone and damage the property.

It's strongly recommended to appoint a licensed builder and licensed plumber immediately to fix this safety defect.

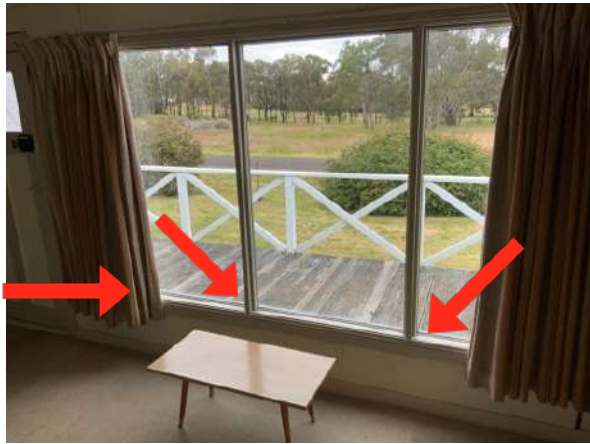
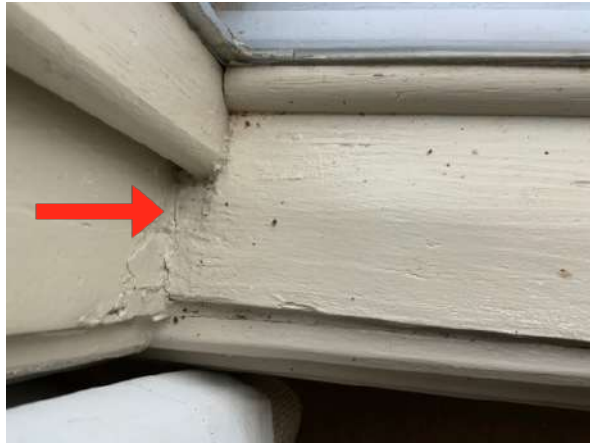
## Major Defect 2.07

**Location:** Lounge room  
**Finding:** Windows Wood Rot (internal)

Wood rot was found to be affecting internal windows. Wood rot, also known as Fungal Decay, occurs when timbers and other cellulose building materials are exposed to damp conditions on an ongoing basis.

It is likely that this wood rot has developed as a result of frequent exposure to rain and other weather conditions from the windows leaking or build up of internal condensation over a long period of time. It is suspected that failure to maintain the window frames over a prolonged period has resulted in them deteriorating at an accelerated rate, increasing their susceptibility to the development of wood rot.

Repair and/or replacement of affected window frames may be a necessary step in protecting surrounding building elements from such deterioration. Remedial works should be performed by a qualified carpenter or an experienced handyman in the near future to prevent any further damage.

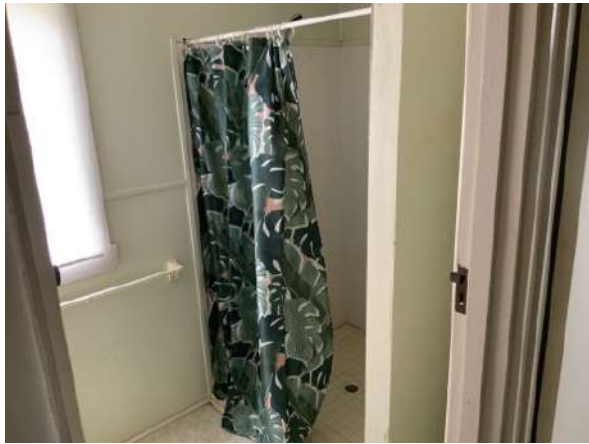
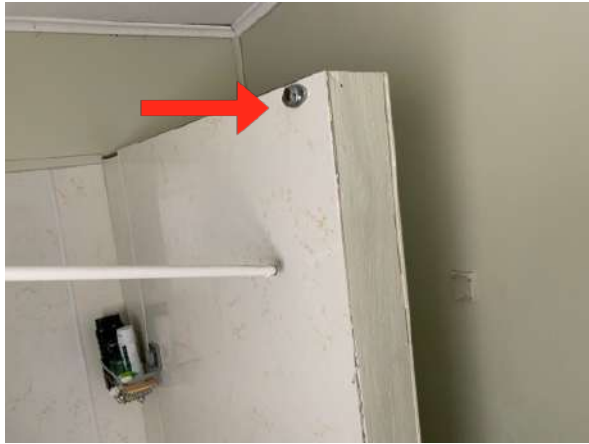
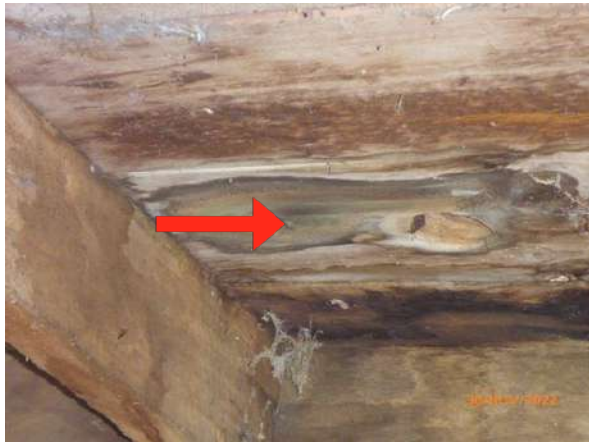
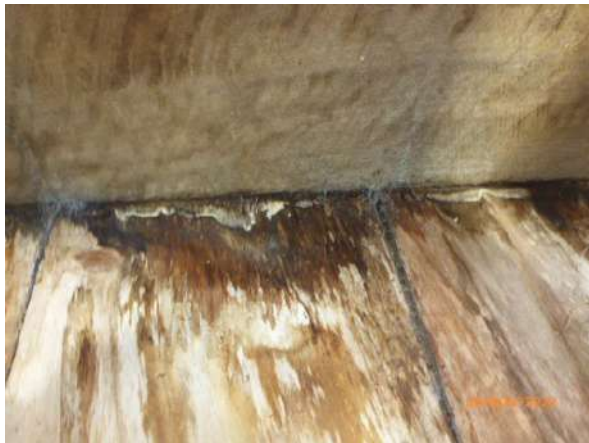
## Major Defect 2.08

**Finding:** Shower water leak (underside evidence moisture, no structural damage)

The underside of the shower area shows evidence of a past or current water leak which appears to have not caused any major wood or structural damage to the building material in this area at the time of the inspection. It's highly recommended to appoint a licensed plumber and a licensed builder into further investigate the water leak and make the required recommendations as soon as possible.

When inspecting the inside of the shower area it was noticed large gaps of missing grout or silicone. The side wall is not fully fixed into place and moves when the shower head rail falls.

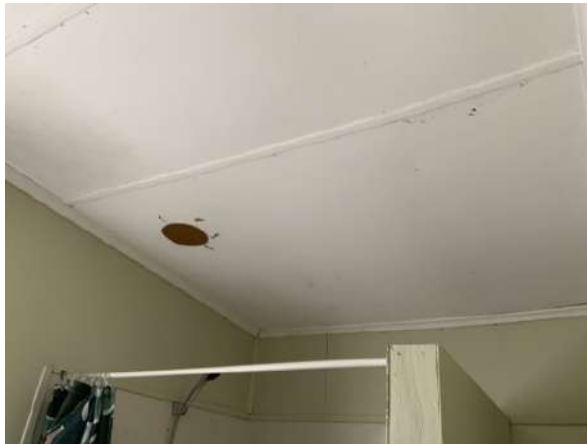
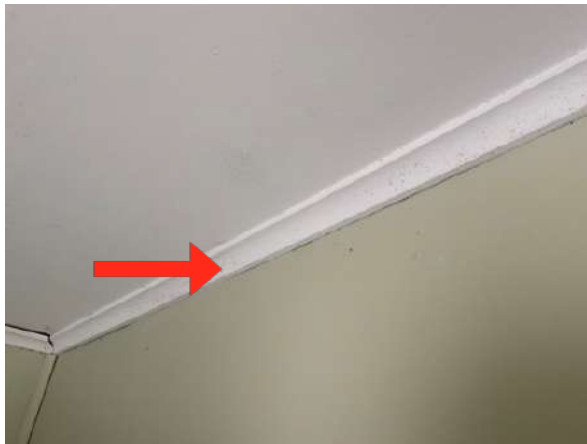
## Minor Defect 3.01

In these areas there appears to be large amount of mould. This could be from lack of ventilation and cleaning.

Generally, the client is advised to ensure that the general environment is free of moisture and humidity to aid in the prevention of mould formation and development. Any mould found during the inspection should be cleaned immediately by a cleaning contractor or the homeowner as applicable. If this is unable to remove this mould or it returns after cleaning than its recommended to appoint a specialist or a qualified environmental health inspector is warranted, where mould is extensive or where any queries regarding air quality spores or other related issues apply.

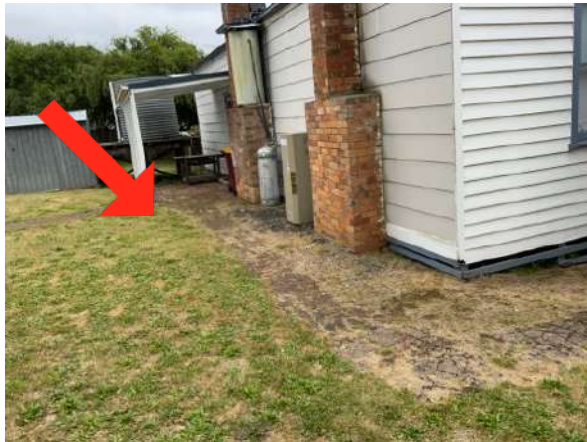
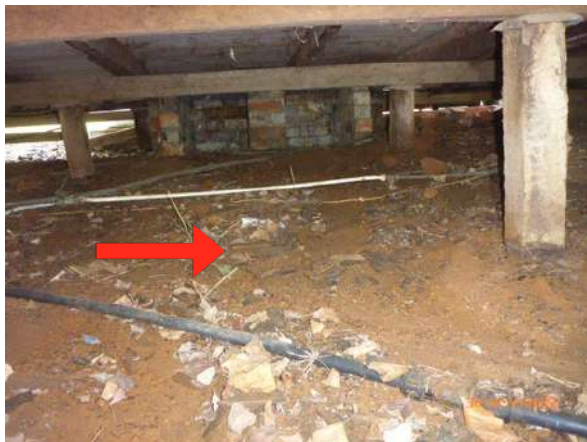
## Minor Defect 3.02

**Finding:** Drainage - Suspected Inadequate

Inadequate site drainage is very common to most homes and was not part of the building regulations when this home was constructed and the responsibility was left to the owner.

It is important that water does not lie underneath the sub floor. If there is a lot of water that continues to lay under the sub floor this may potentially cause the sub floor structures to deteriorate resulting in uneven movement of the footings and foundations, promote wood rot (if timber stumps are present) and attract termite activity.

Where site drainage is inadequate, installation of an Agricultural (Aggie) Drain may be required. A qualified plumber should be appointed to further inspect the property and perform any remedial works as necessary. Water damage and secondary defects are likely to occur if left unmanaged.

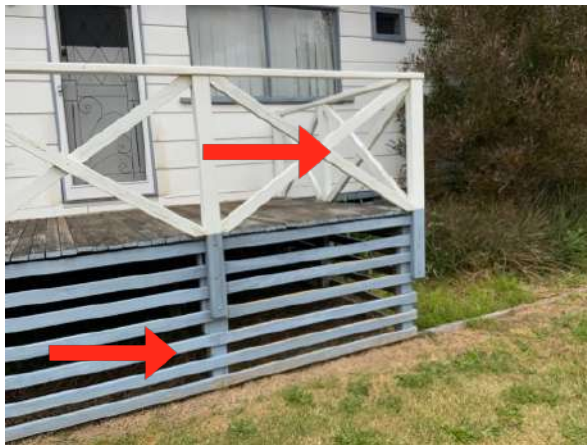
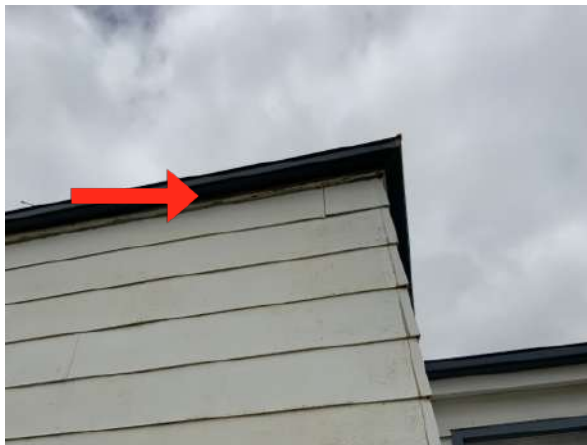
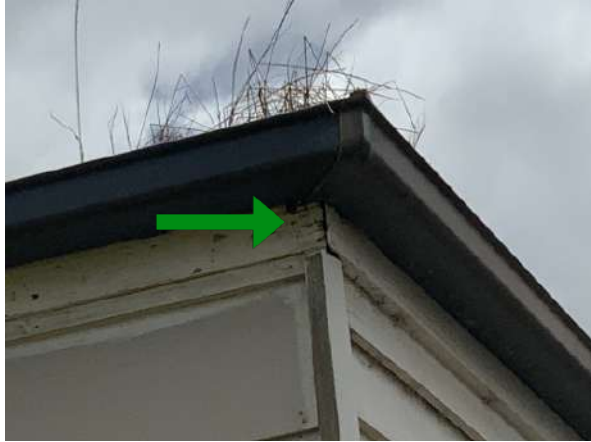
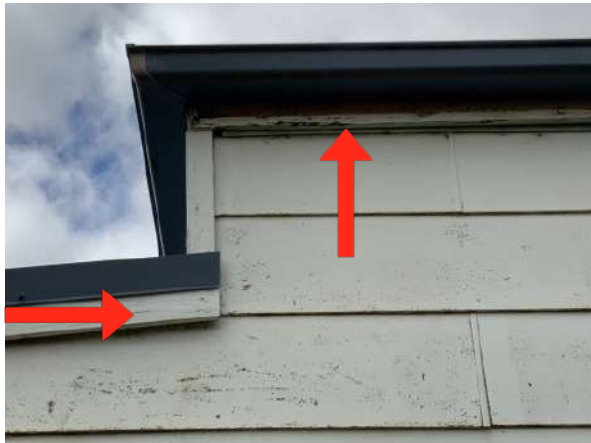
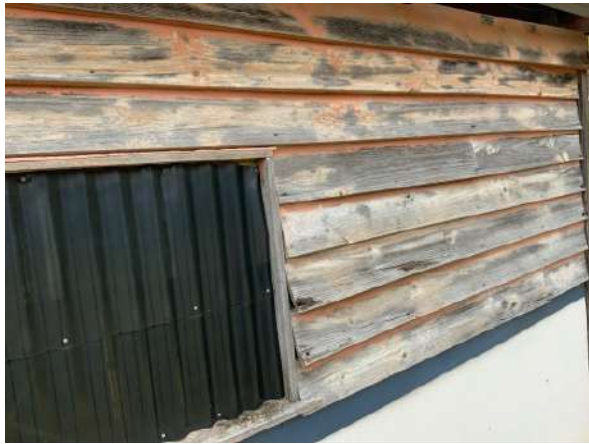
## Minor Defect 3.03

External timbers that are frequently exposed to harsh weather conditions require adequate protection in order to maintain their condition. Where timbers have not been painted or treated adequately, general deterioration is likely to occur at an accelerated rate.

If left unattended, replacement of these timbers is likely to be necessary in the short-term. To prolong the life of these timbers it is recommended you seek the services of a painting contractor or general handyman as a short term priority.

A qualified carpenter or registered builder may be required to replace affected building materials.

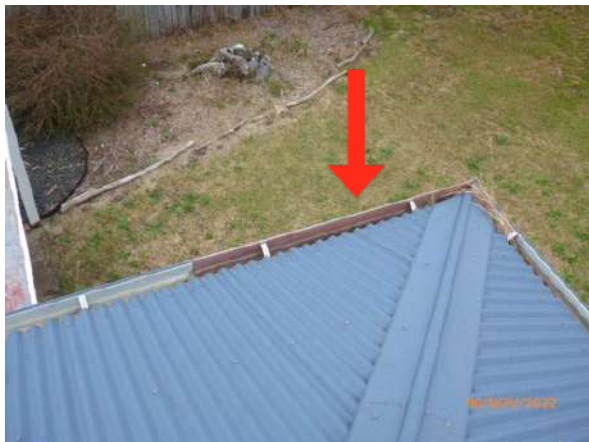
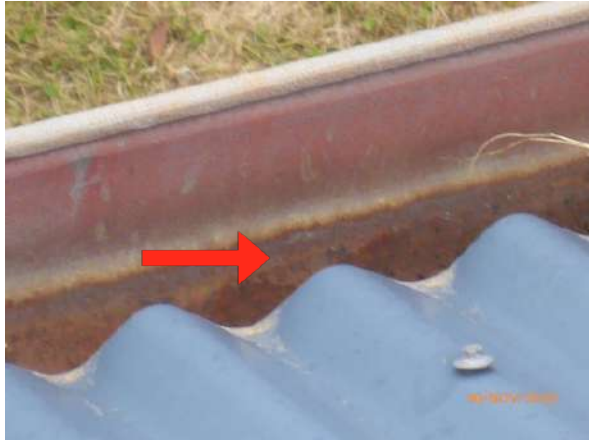
### Minor Defect 3.06

**Finding:** Rusty gutters

The guttering and downpipes on the house are corroded with some holes evident. This should be rectified as soon as possible as excessive moisture can lead to foundation issues as well as conditions conducive towards timber pest activity. An investigation (by a competent person e.g. a licensed plumbing contractor) is recommended as soon as possible to determine the method and extent of any remedial work required and associated costs.

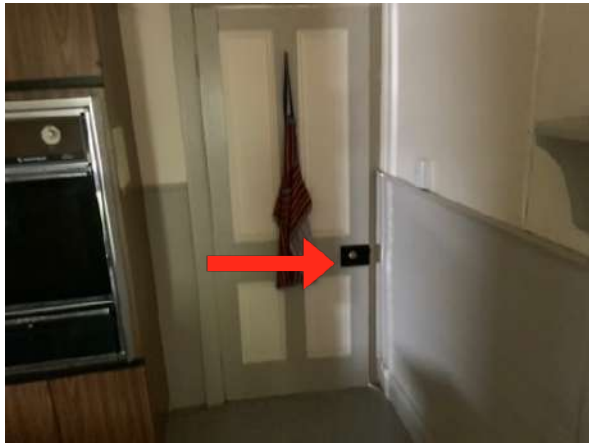
### Minor Defect 3.07

This is a common defect and is expected in a property of this age, whether being due to substandard installation or general deterioration of the door hardware.

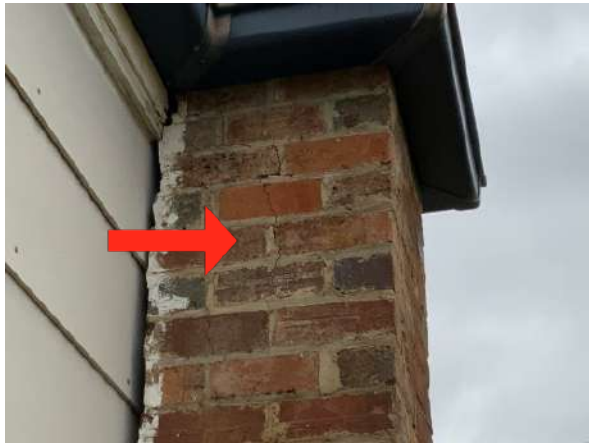
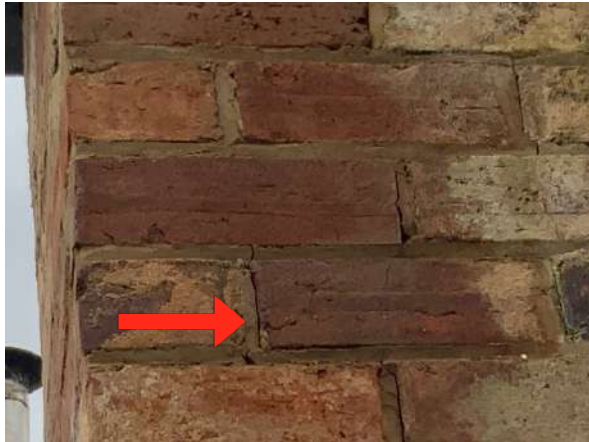
### Minor Defect 3.08

**Finding:** Brickwork - Cracking

Although fine cracks are quite noticeable, they are often only considered to be an appearance defect and usually do not indicate any structural damage. Generally, the cause of a fine crack is indicative of a separation between brickwork and mortar throughout the structure, but single bricks may also show cracks of this nature.

Always contact a building inspector should cracks widen lengthen or become more numerous.

Cracking of this nature can generally be repaired with minor filling and should be conducted by a qualified bricklayer.

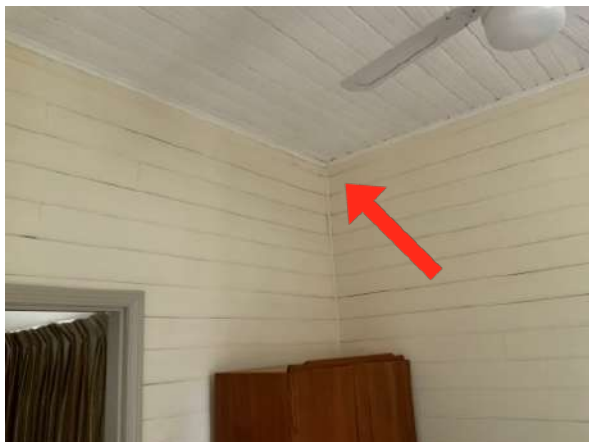
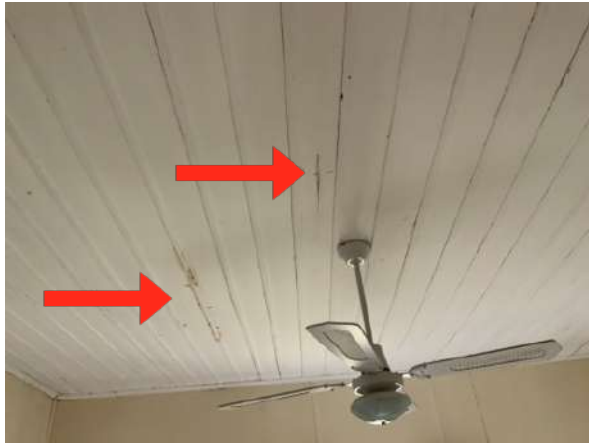
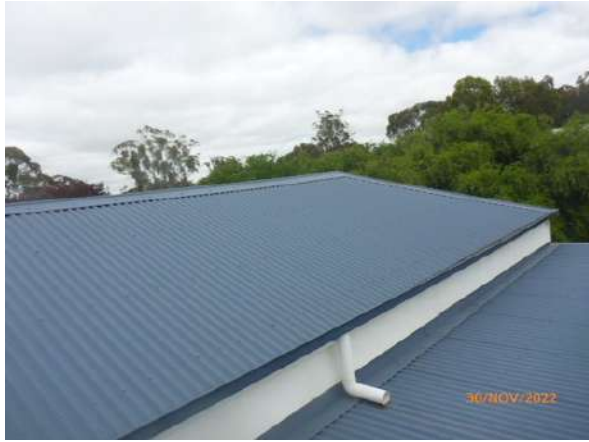
### Minor Defect 3.09

**Finding:** Ceiling - Water damaged (suspected old newer roof)

Water damage to the ceiling lining in this area is generally an indication of excessive moisture being present, usually via a leak to the roof covering; however, when inspecting the external roof it appears that the roof has been recently sometime ago been replaced. It's highly recommended to monitor this defect area over a period of time and if there is any current activity then a roofing plumber should be appointed as soon as possible to identify the leak and perform rectification works as necessary, ensuring the water damage is restricted.

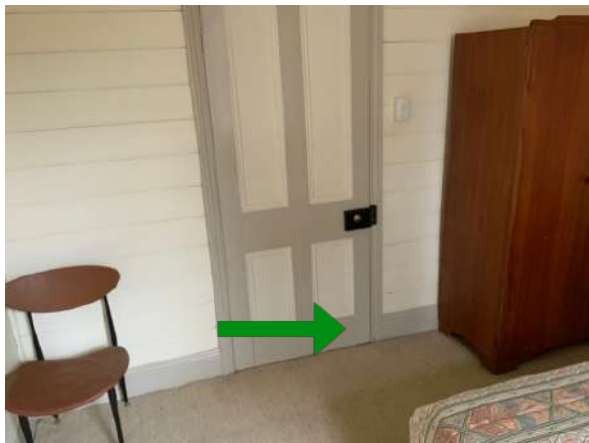
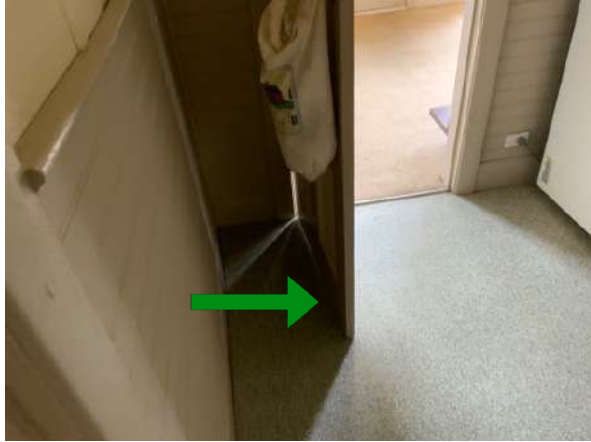
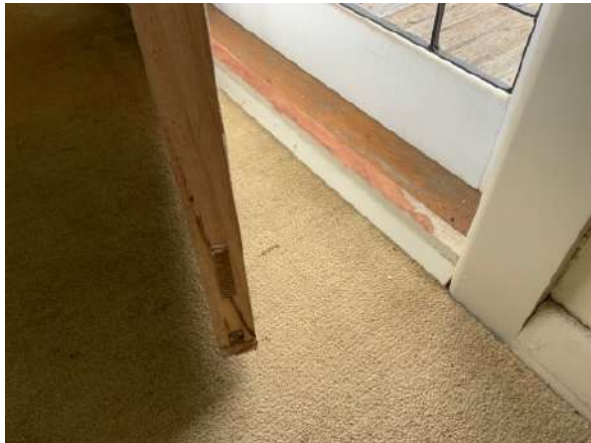
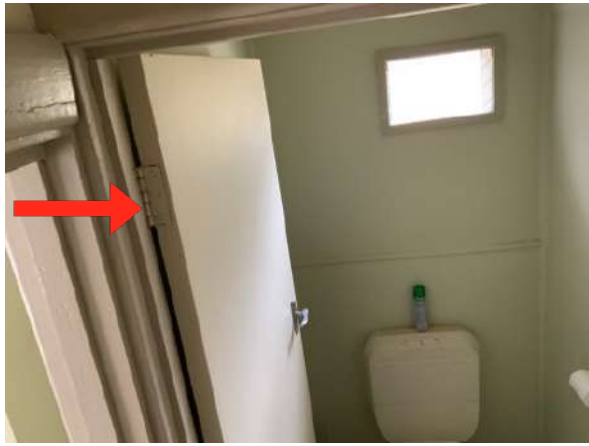
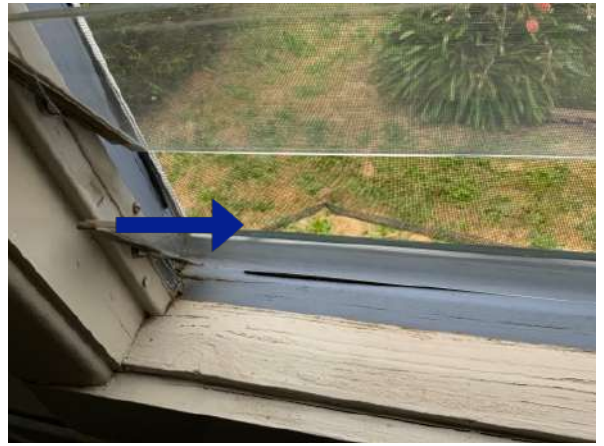
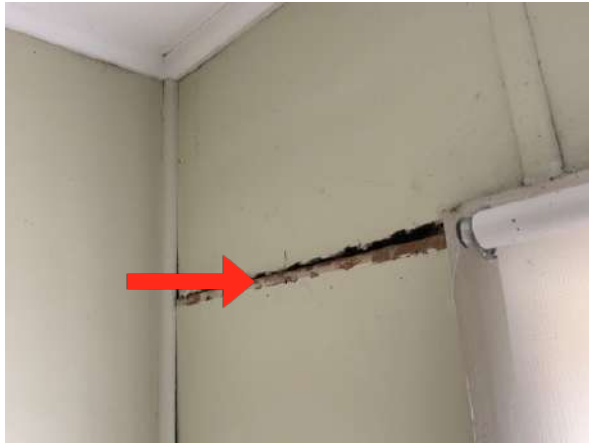
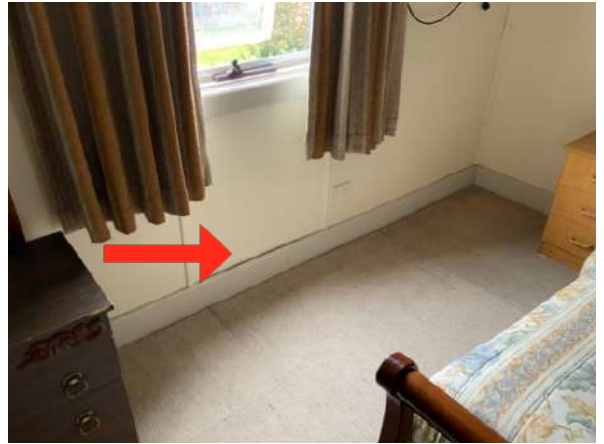
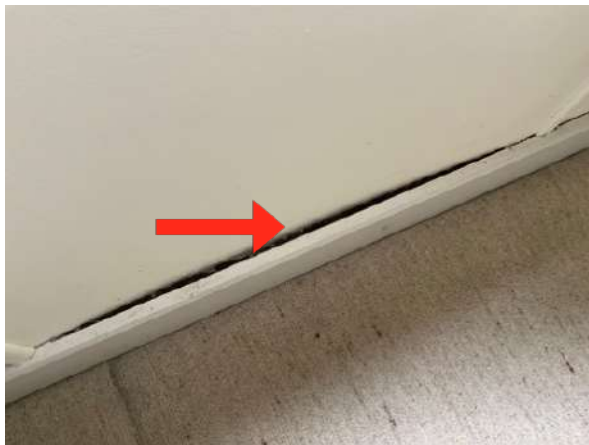
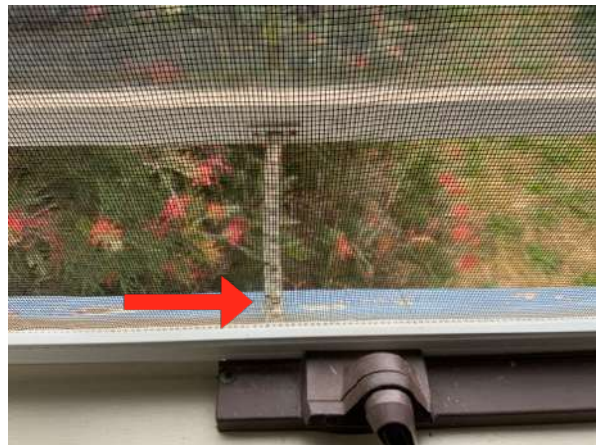
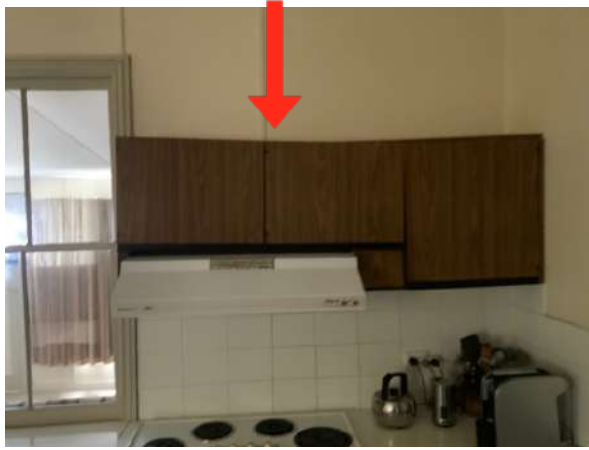
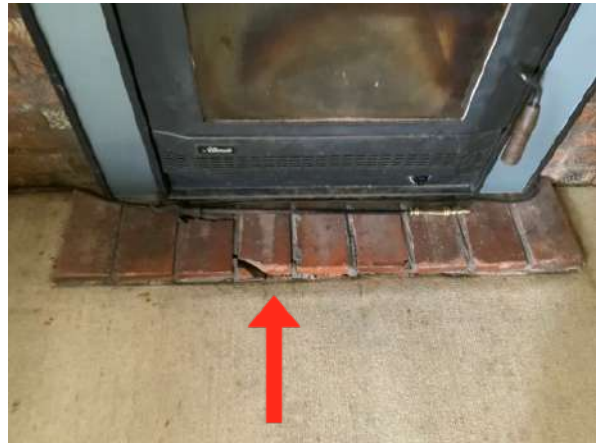
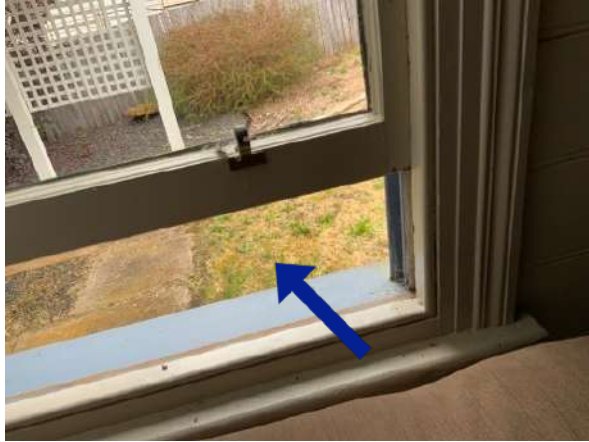
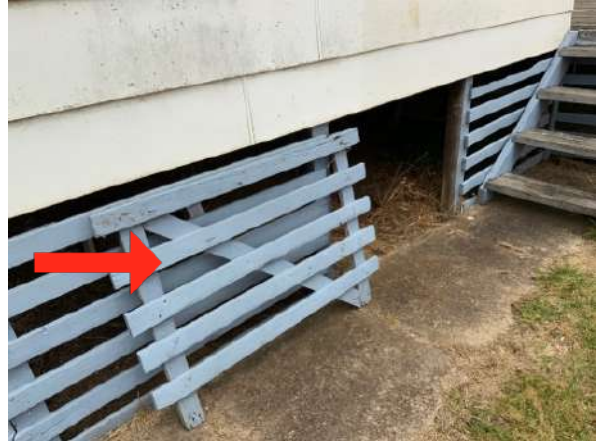
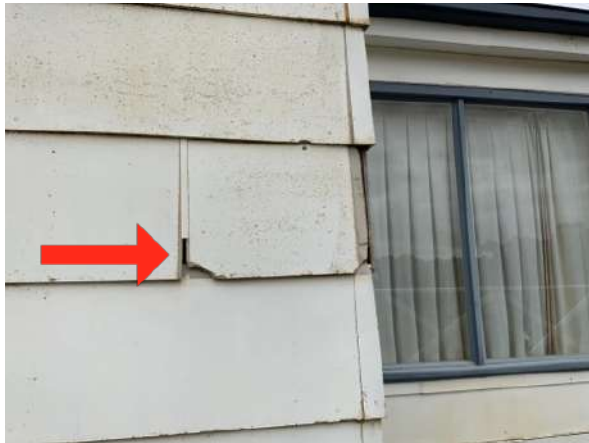
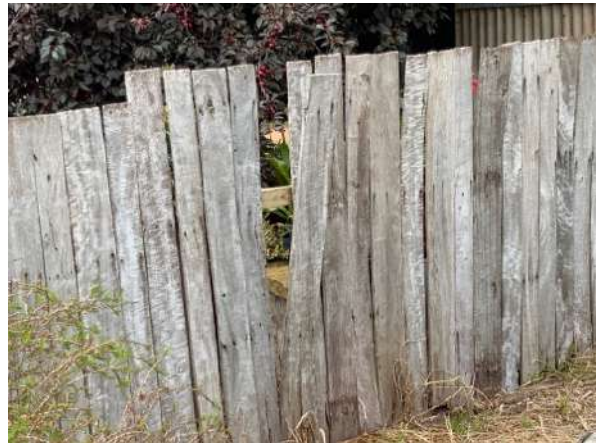
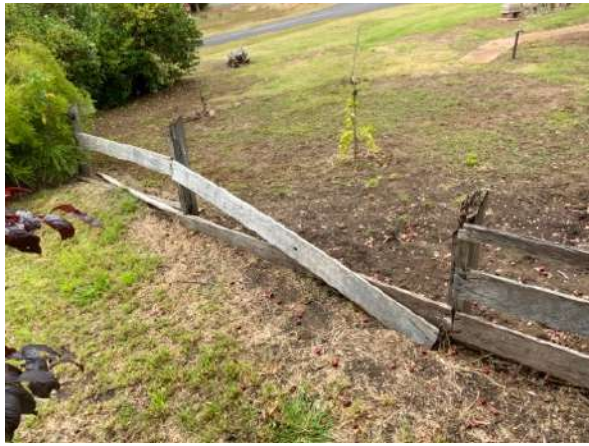
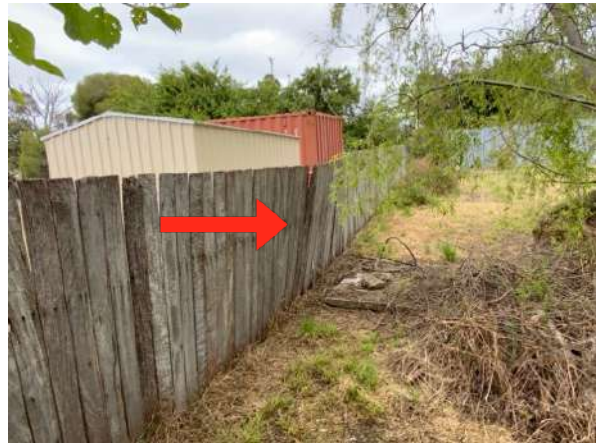
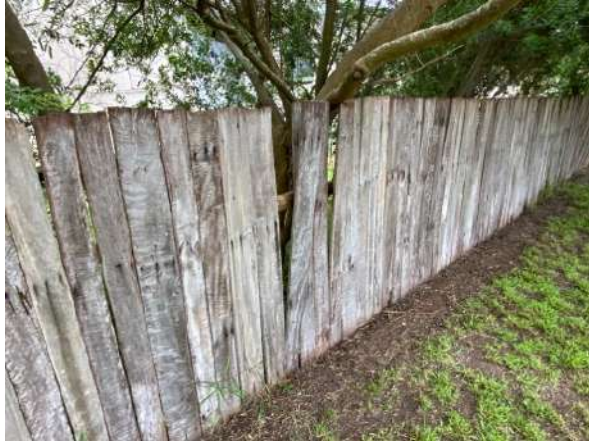
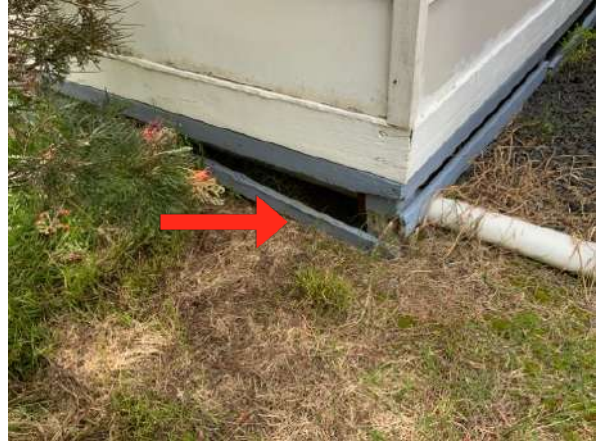
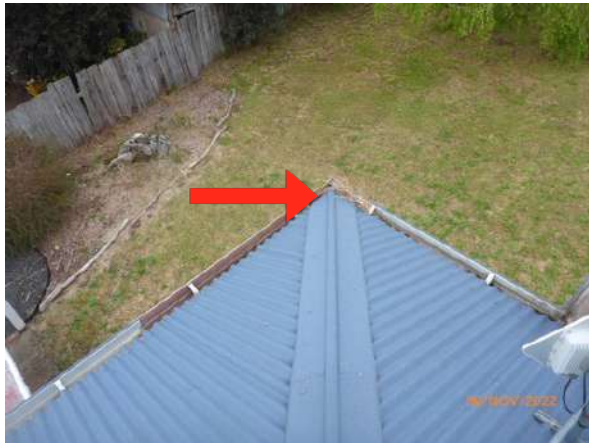
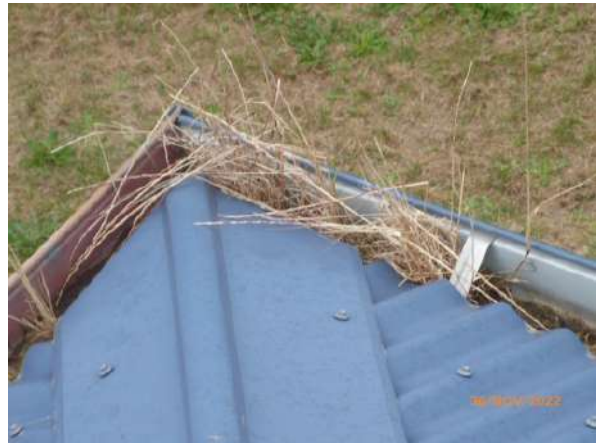
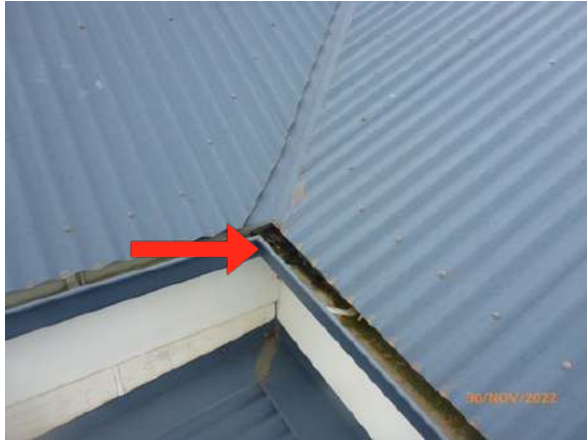
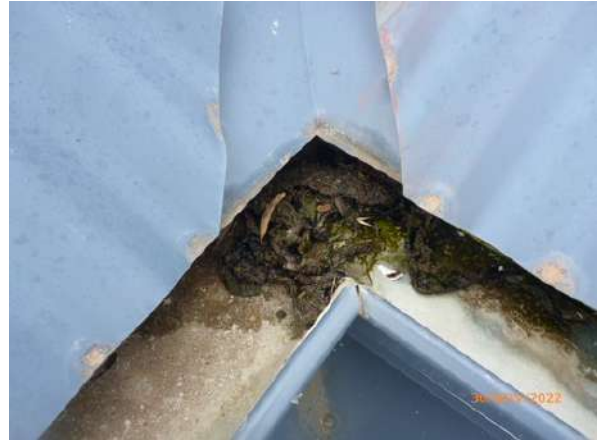
### Minor Defect 3.10

The following listed items are minor maintenance issues that should be addressed in the near future. Only a portion of some maintenance items are listed. But given the age of the home multiple instances of deterioration are to be expected and not all documented.

Photos are attached to help you identify these areas. (Please note they are not necessarily in this order)

- Missing or damaged door stops (refer to the green arrows).
- Missing or damaged fly screens (refer to the blue arrows).
- Fencing deteriorated.
- Roof gutters blocked.
- Skirting boards not fully nailed back to the wall includes missing cover straps.
- Toilet door missing lift up hinges.
- Damaged subfloor door.
- Window winders need some lubricants.

These are common maintenance items that all home owners should undertake on a regular basis to ensure longevity of building materials and prevent damage and deterioration of building elements.

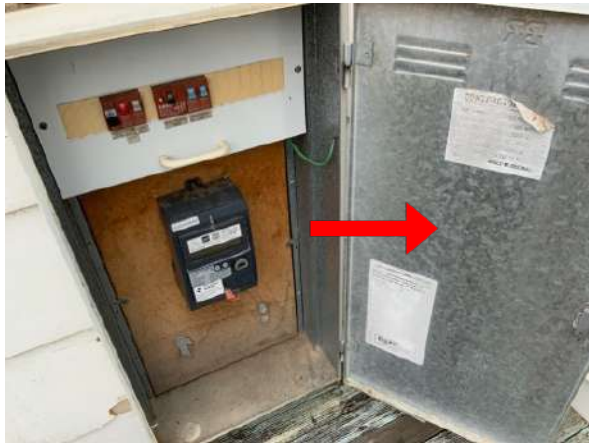
A durable notice should be placed in the switchboard unit to indicate current termite barriers. At the time of inspection, it appeared as though no termite management system has been installed, with no evidence to suggest preventative works taking place.

The application of a post-construction chemical termite barrier is highly recommended for all properties, particularly if live termite activity has been found on the site previously. Such barriers are highly effective in preventing termite attack on any timber building elements throughout the property.

The client may consider gaining further advice from a pest controller as to the costs and procedures involved with this application. It is recommended that obtaining such advice be a short-term priority.

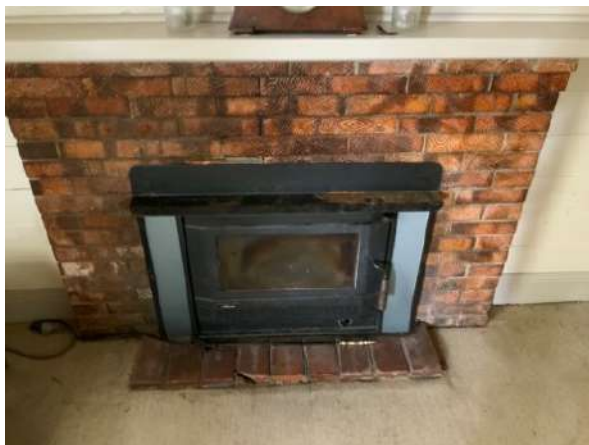
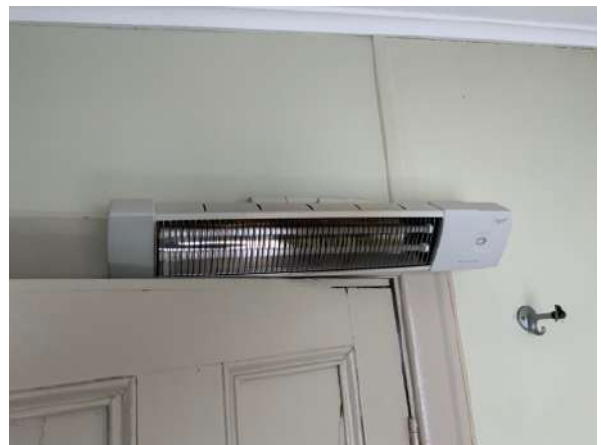
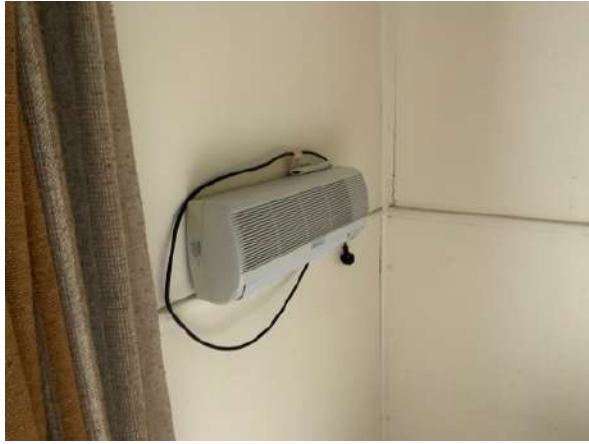
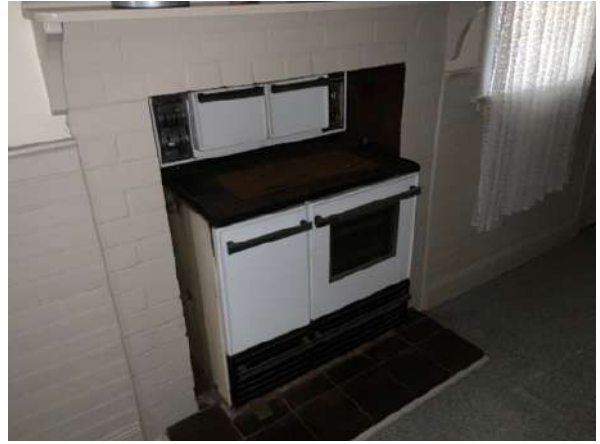
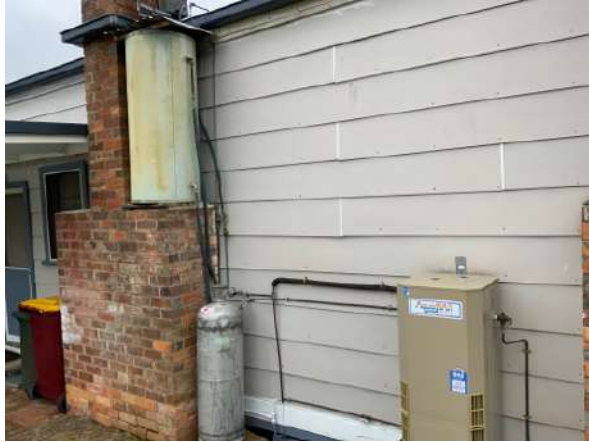
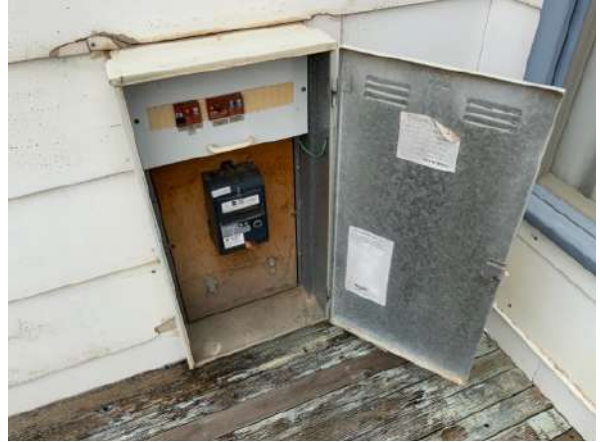
### Observation 4.02

All gas and electrical appliances need to be serviced and maintained in good order. Plumbing and electrical inspections are outside the scope of the building inspection and must be conducted by a Licensed and registered Trades person. It is highly recommended that the client makes immediate arrangements to have the gas appliances and electrical appliances (condition of any electrical in the property) checked by a licensed gas plumber and a licensed electrician to ensure that the appliances are working safely and efficiently. We recommend all other installations be checked also.

Whilst we note and comment of visually apparent defects that present during the building inspection, legislation requires the checking and documenting of compliance for plumbing and electrical requirements be done by licensed electrician and plumbers respectively to ensure they are functioning correctly.

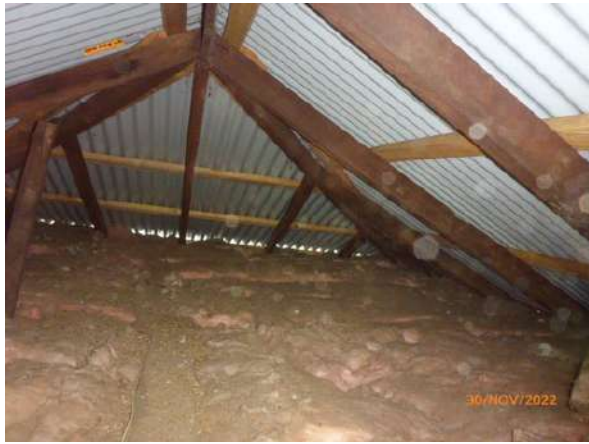
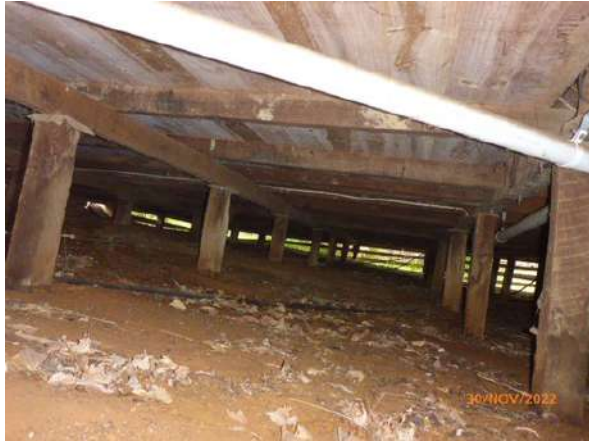
### Observation 4.03

These photographs are an indication of the obstructions and limitations which impeded full inspection of the roof void and subfloor lack of height at the time of inspection. Please refer to the pre inspection agreement.

It is recommended a further inspection of the roof void and subfloor be conducted once suitable access has been provided.

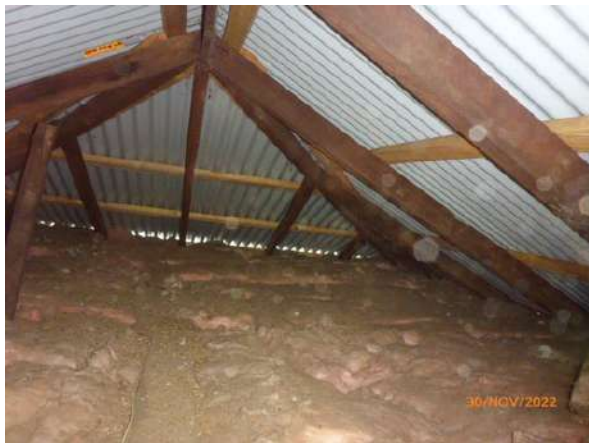
### Observation 4.04

**Finding:** Insulation coverage Upon inspection of the roof void it was noted that there is a good coverage of insulation.

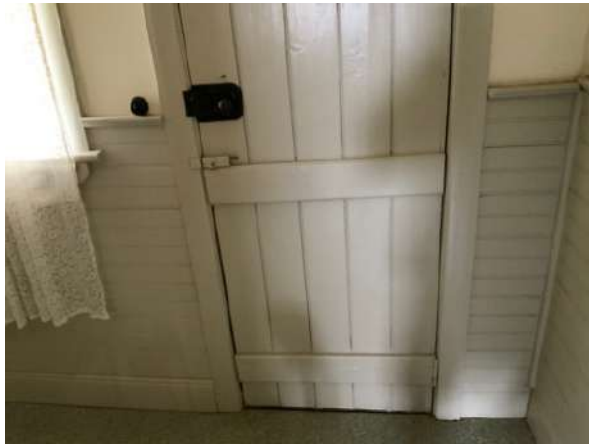
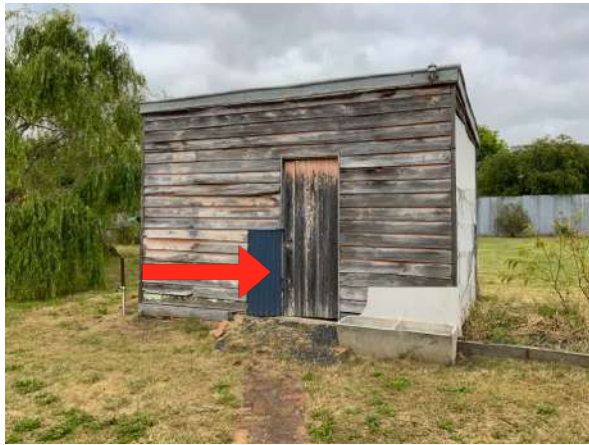
These areas were locked at the time of the inspection. So the area behind the locked door was not inspected.

It's recommended to have this area inspected when this area is fully accessible.
