# Building Inspection

Inspection Date: 30 Nov 2022

## Forsyth Inspections

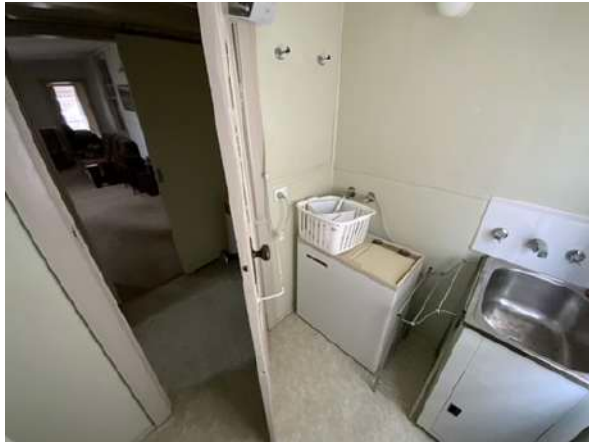
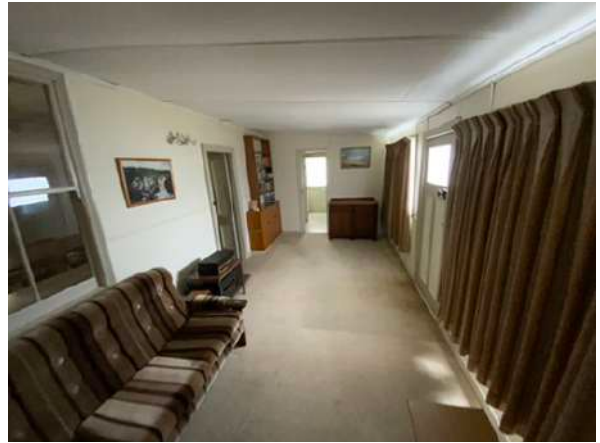
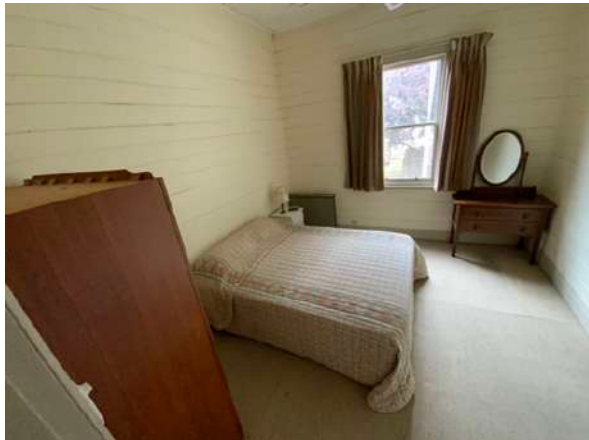
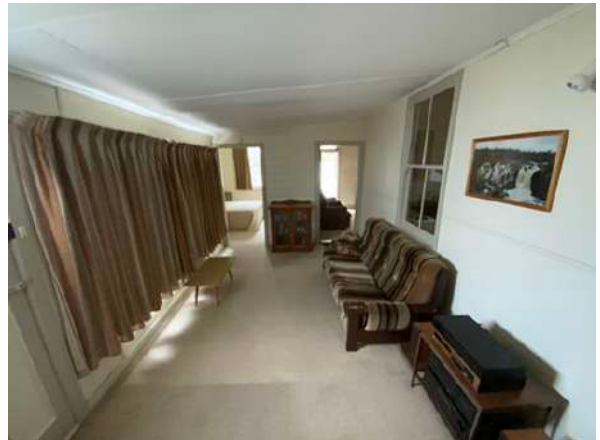
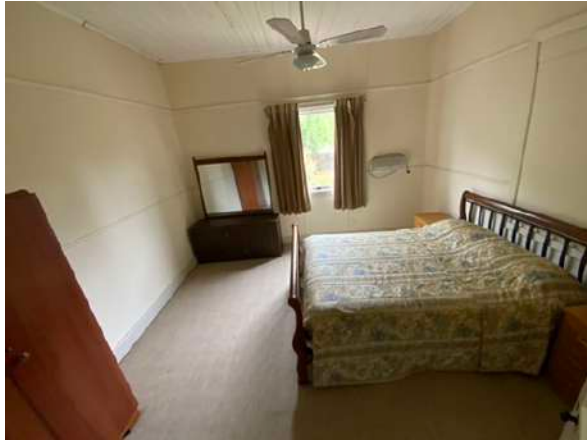
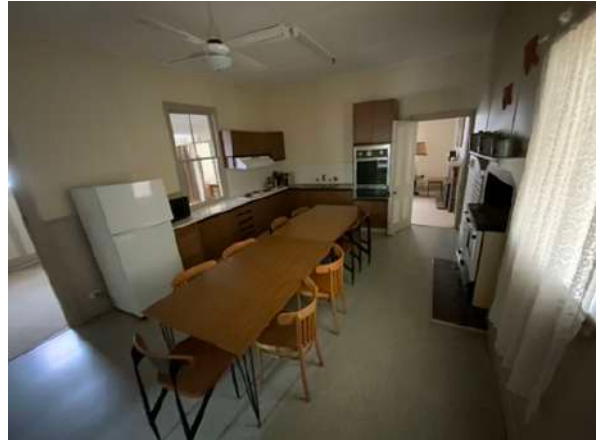
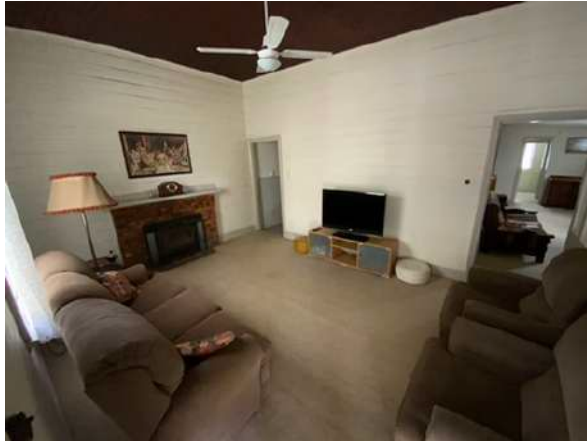
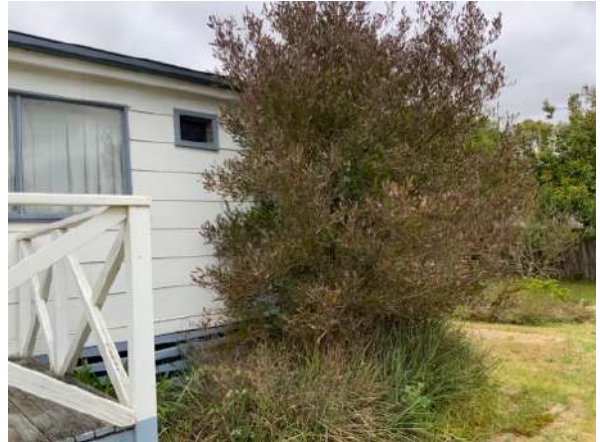
## Observation 4.06

**Location:** All areas

- Personal Items - Furniture, equipment, clothing
- Stored Items
- Floor coverings
- Window coverings
- Wall and ceiling linings
- External walls
- Roof voids
- Roof coverings ( tiled roofs and tin roofs are visually inspected from not leaving the ladder @ 3.6 meter max height)
- Sub floors
- Sheds, equipment

The limitations described above, are not intended to be an exhaustive list and we endeavour to identify any limitations or restrictions specific to the property as soon as possible. A re-inspection of areas that are obstructed or limited should be conducted once the access has been provided.
